INSPECTION REPORT

For the Property at:
27 MAPLE CRESCENT
CHICAGO, IL

Prepared for: JOHN SIMPSON
Inspection Date: Thursday, January 4, 2007
Prepared by: Alan Carson

RE: Report No. 1366, v.6
27 Maple Crescent
Chicago, IL

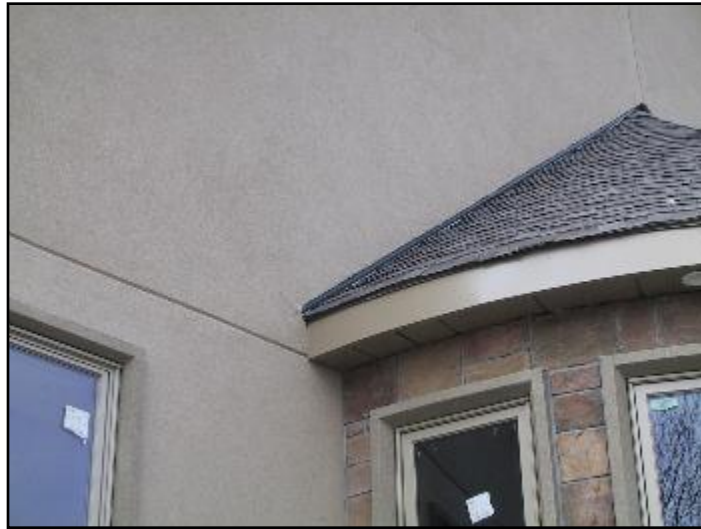
Condition: • [No kickout flashing](#)

Implication(s): Chance of water damage to contents, finishes and/or structure

Location: North First floor

1. No kickout flashing at roof/sidewall junction

Task: Improve

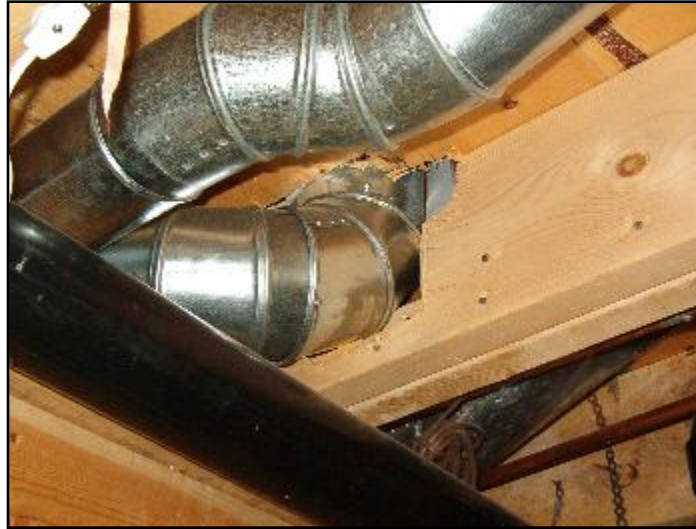
Condition: • [Notches or holes](#)

Implication(s): Weakened structure

Location: West Basement

4. Double joist cut for ductwork

Task: Repair

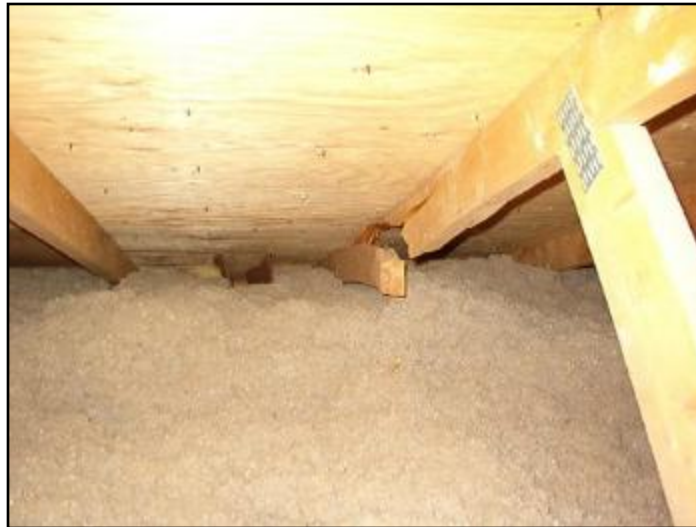
Condition: • [Split](#)

Implication(s): Weakened structure | Chance of structural movement

Location: Northeast Attic

5. Top chord of truss is broken

Task: Repair or replace

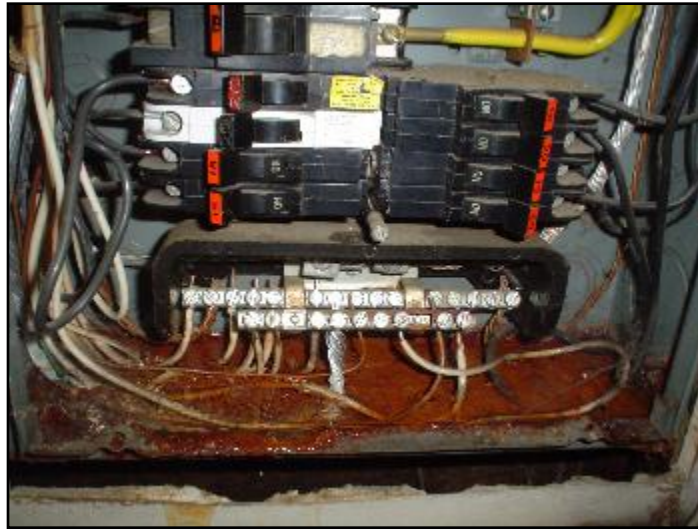
Condition: • [Rust or water in panel](#)

Implication(s): Electric shock | Fire hazard

Location: North Basement

6. Water and rust in bottom of panel

Task: Replace

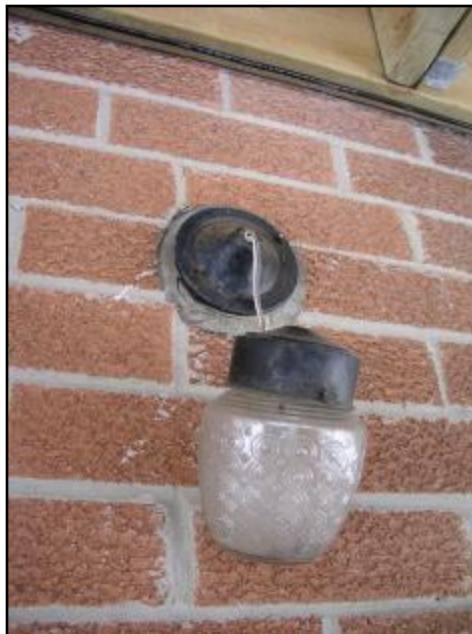
Condition: • [Loose](#)

Implication(s): Electric shock | Fire hazard

Location: East Exterior wall

7. Light fixture is not well secured

Task: Repair or replace

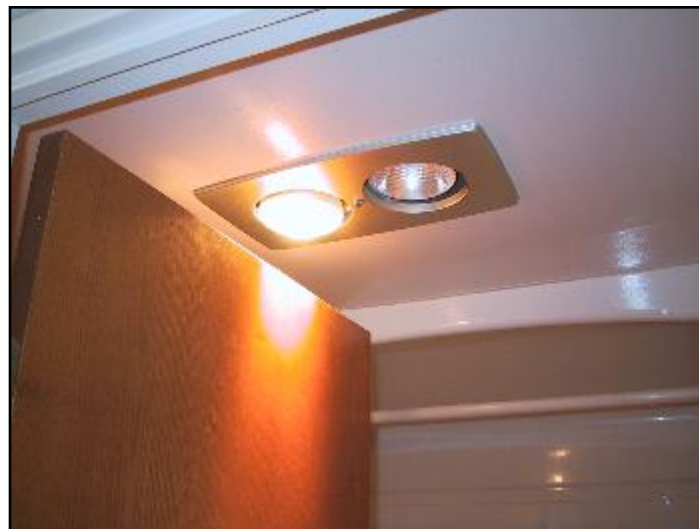
Condition: • [Heat lamps over doors](#)

Implication(s): Fire hazard

Location: East Second floor Bathroom

8. Heat lamp over door - fire hazard!

Task: Correct

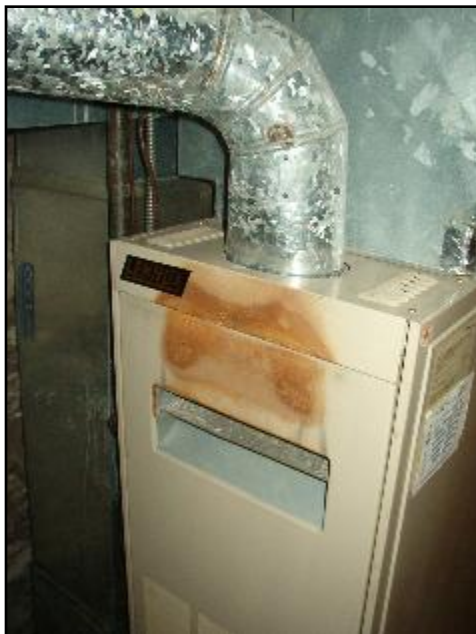
Condition: • [Draft hood spillage or backdraft](#)

Implication(s): Equipment not operating properly | Hazardous combustion products entering home

9. Evidence of furnace backdrafting

Task: Correct

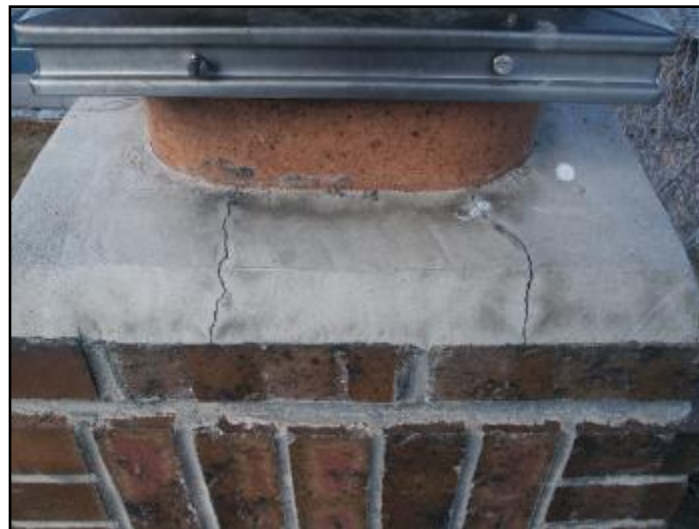
Condition: • [Cracked](#)

Implication(s): Chance of water damage to contents, finishes and/or structure | Shortened life expectancy of material

12. Minor cracks in chimney cap

Task: Repair

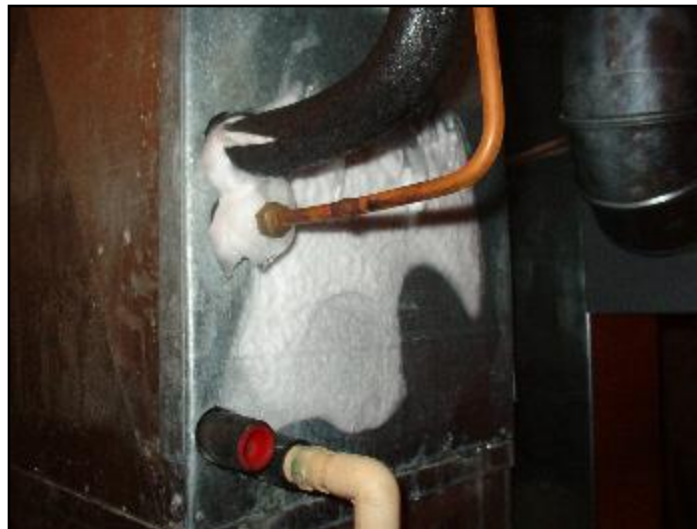
Condition: • [Frost](#)

14. Frost visible on ductwork at AC coil

Task: Repair

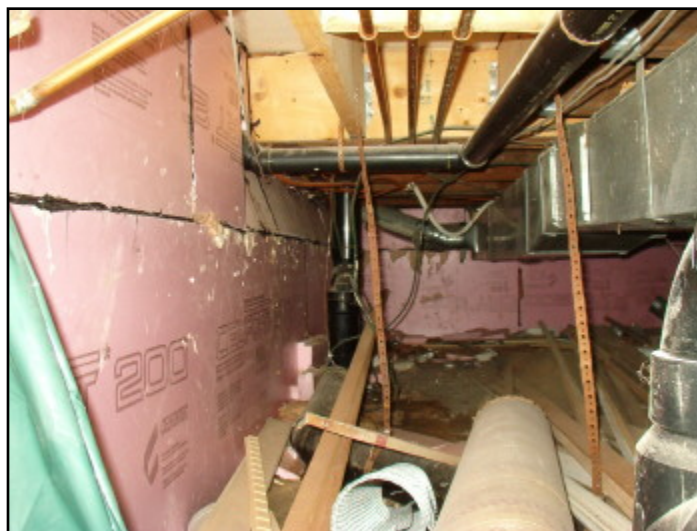
Condition: • [Exposed combustible insulation](#)

Implication(s): Fire hazard

15. Exposed polystyrene insulation is fire hazard

Task: Remove or cover with drywall

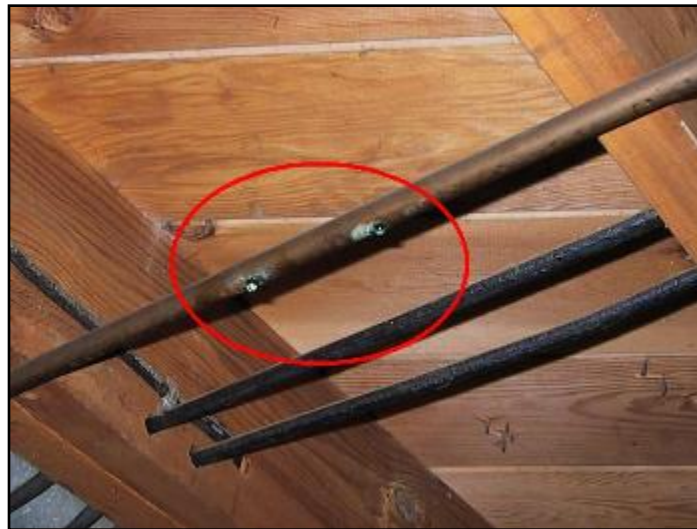
Condition: • [Leak](#)

Implication(s): Chance of water damage to contents, finishes and/or structure | System inoperative

16. Leaking copper supply pipe

Task: Repair

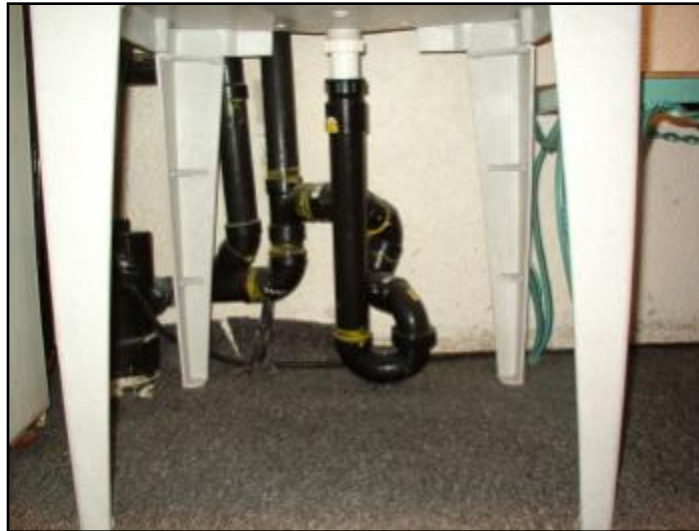
Condition: • [Nonstandard shape or material](#)

Note: This configuration is prone to clogging problems

17. Poor trap arrangement

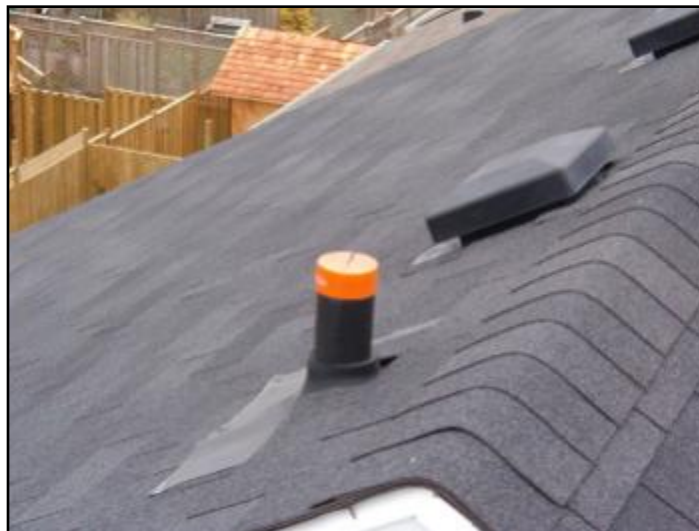
Condition: • [Vent termination problems](#)

18. Plumbing stack is capped

Task: Remove cap

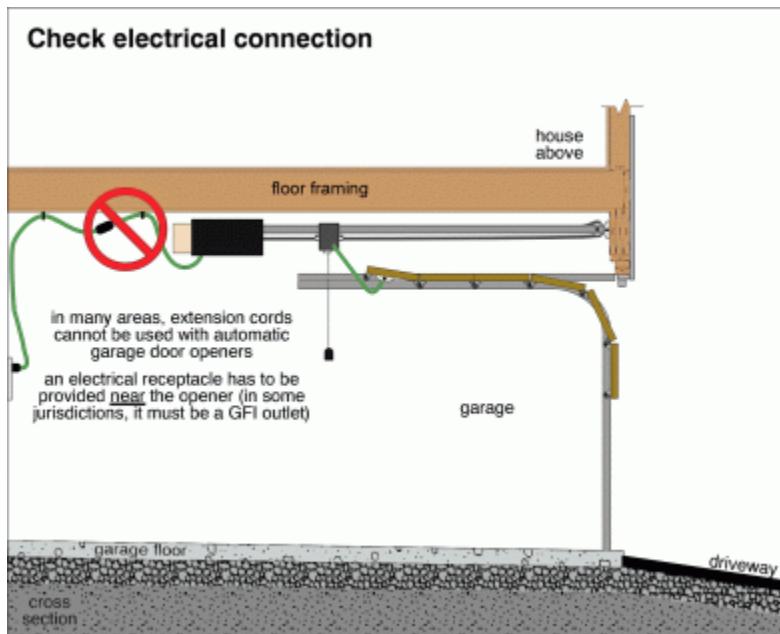
Condition: • [Extension cord for opener](#)

20. Extension cord for west garage door opener

Task: Replace with permanent wiring

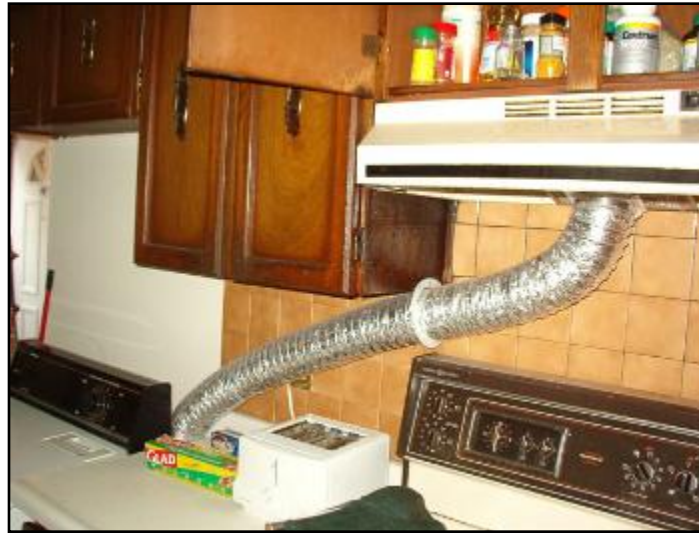
Condition: • The clothes dryer is vented into an exhaust fan designed for a stove. This unconventional installation should be re-arranged.

22. *Clothes dryer vented incorrectly*

Task: Improve
