# YOUR INSPECTION REPORT

1840 E. Cedar Avenue  
Denver, CO 80209

Friday, October 23, 2015

RE: Report No. 3912, v.2  
1840 E. Cedar Avenue  
Denver, CO  
80209

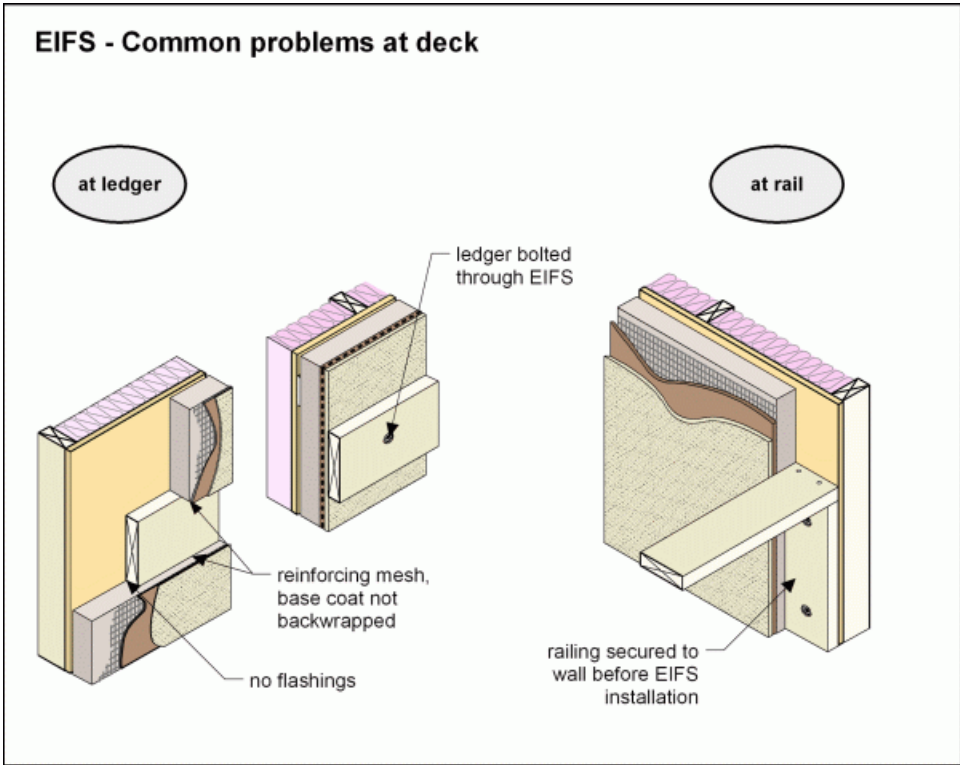
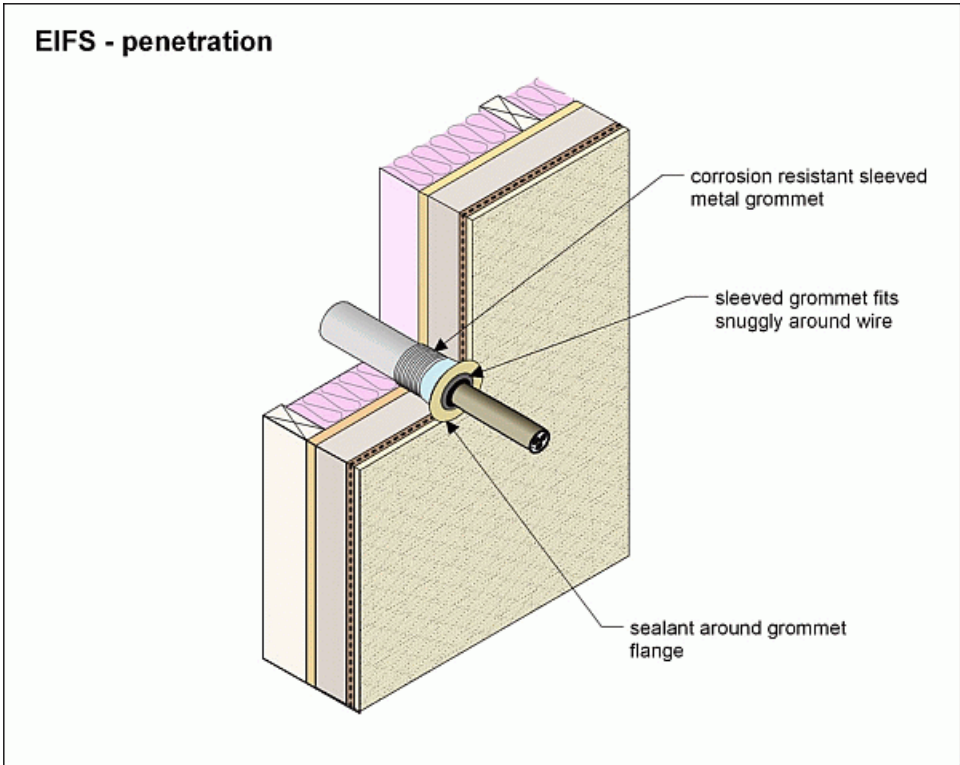
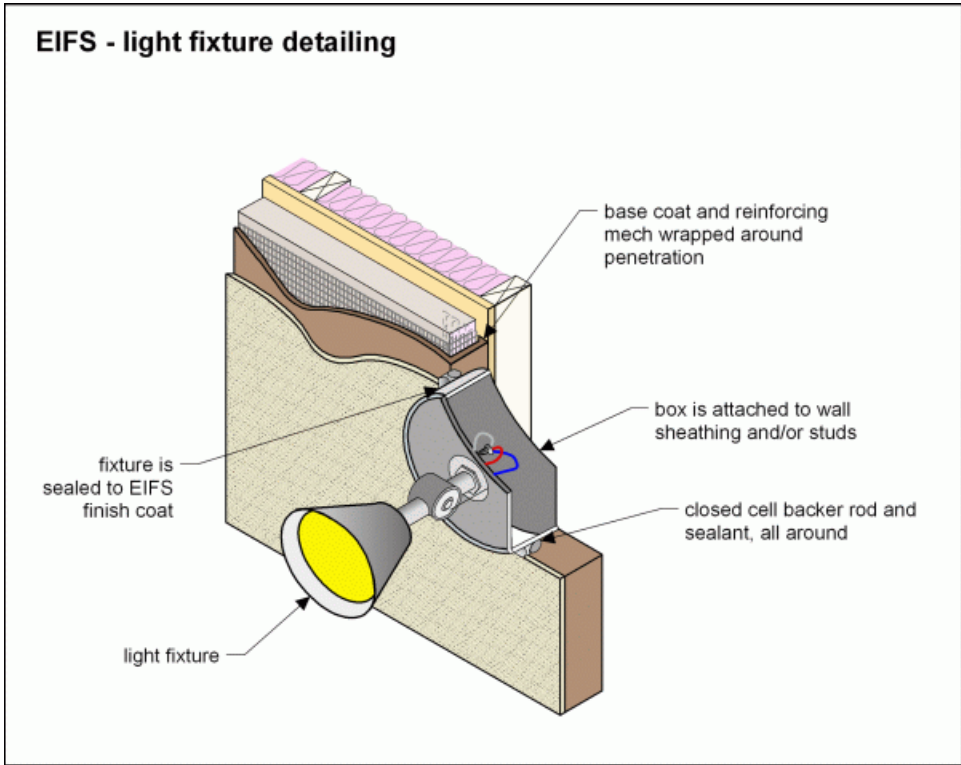
The seller disclosed that they had to have the stucco repaired on the front side of the home due to moisture intrusion. It appears that repairs were made, however there was a very musty smell in the master bedroom during the inspection. This is a possible indication that water may have entered inside the wall cavity and was not addressed properly during the stucco repairs. This raises concerns related to possible mold and material deterioration inside the wall cavity. Recommend further evaluation and a mold test be conducted by the appropriate professionals.

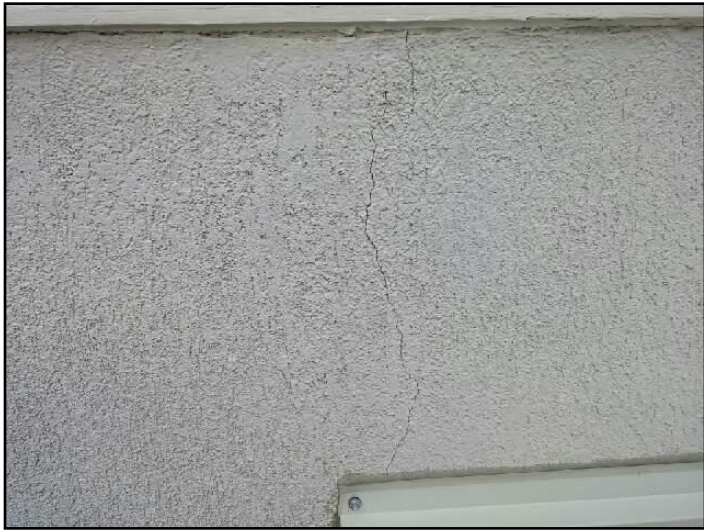
There were cracks in the stucco at various points of the exterior at the time of the inspection. Over the years, cracking of this material is typical for a stucco wall as it shrinks. However, the envelope of home should be properly sealed to prevent moisture from entering behind the stucco and becoming trapped. Recommend having these cracks repaired by a qualified stucco professional.

*Cracks in Stucco*

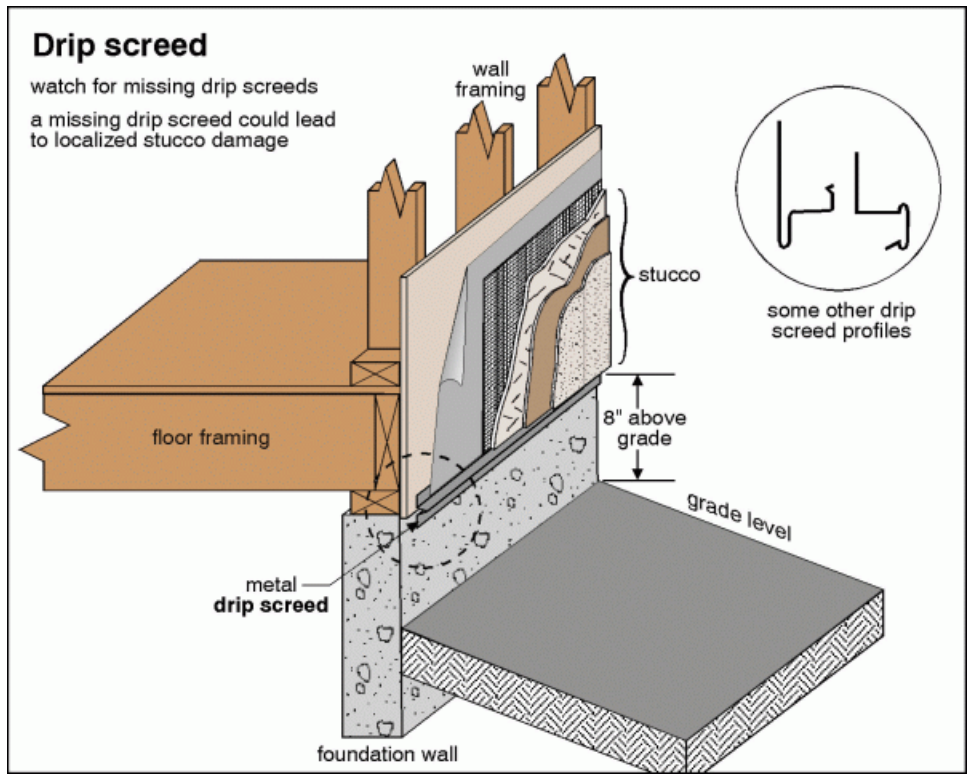
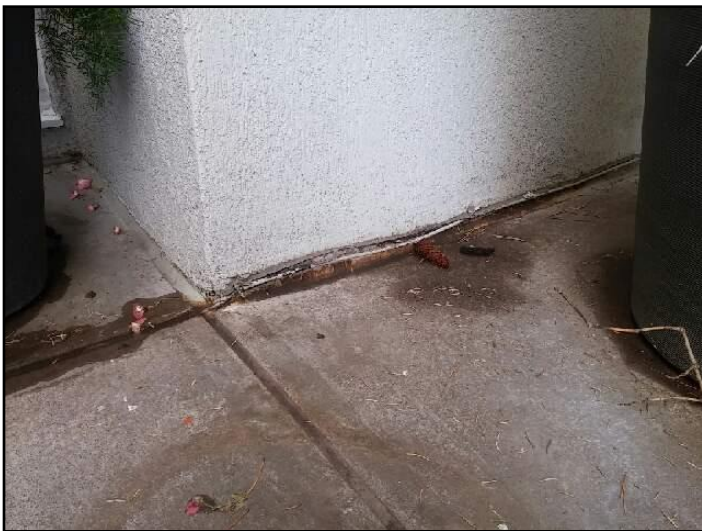
The stucco was too close to grade and in contact with concrete at various points at the exterior wall (see photos), at the time of the inspection. There were no real regulations on stucco installation until 1997. Stucco should be at least 4" from soil and 2" from concrete type surfaces. Recommend having the stucco evaluated by a qualified stucco professional to determine what steps can be taken to ensure that the stucco wall will drain properly, since the previous owners disclosed that they had moisture penetration occur on the front side of the home.

*Too Close to Grade*

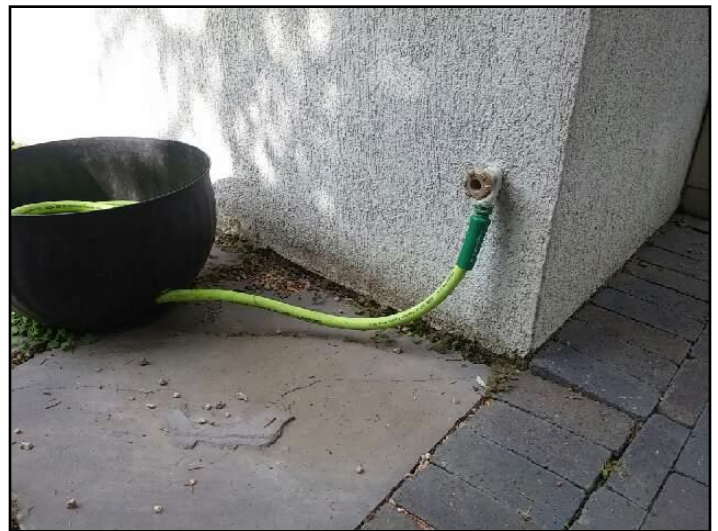
*Too Close to Grade*

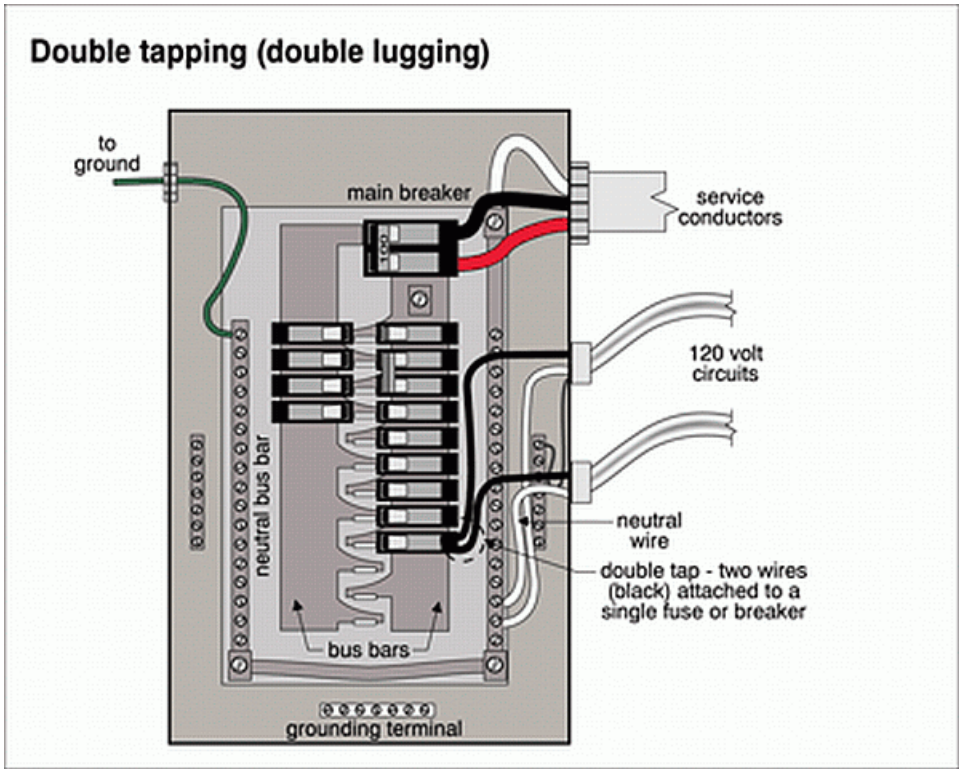
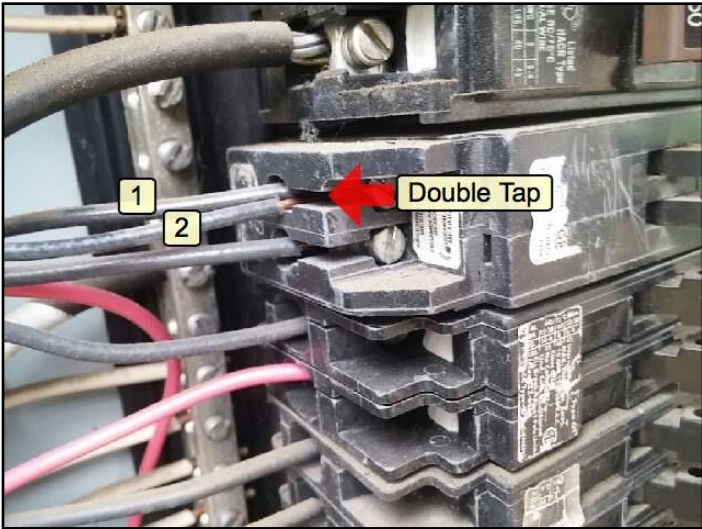
There was a single pole circuit breaker improperly double tapped, at the electrical distribution panel, with two wires entering the single pole breaker (see photo). Most circuit breakers and other electrical connections are only rated (UL listed) to safely hold one wire. Double tapping is when 2 or more wires connect to one circuit breaker or electrical lug. Recommend repairs to these circuit breakers by a qualified electrical professional, keeping in mind that there is a spare circuit breaker already in the panel that can be used for one of these wires.

*Electrical Distribution Panel - Double Tap*

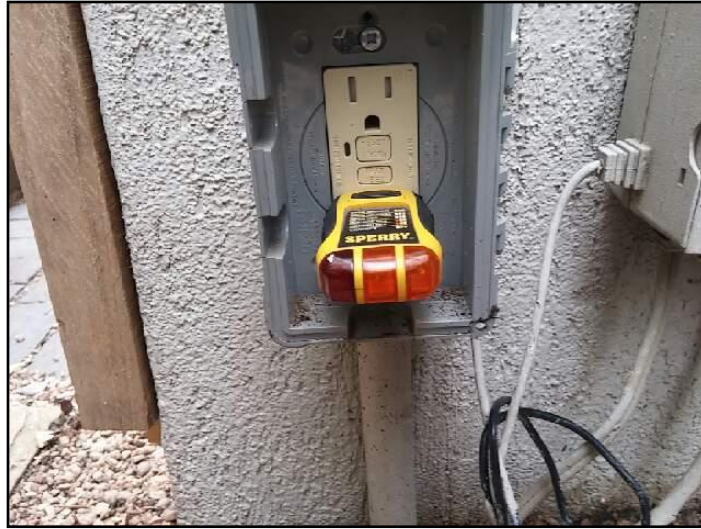
The ground fault circuit interrupter (GFCI) device by the AC compressors (East exterior wall) would not trip as intended at the time of the inspection. Recommend further evaluation and repairs or replacement of this GFCI device as necessary by a qualified electrical professional.

*AC Service Outlet - East Exterior Wall*

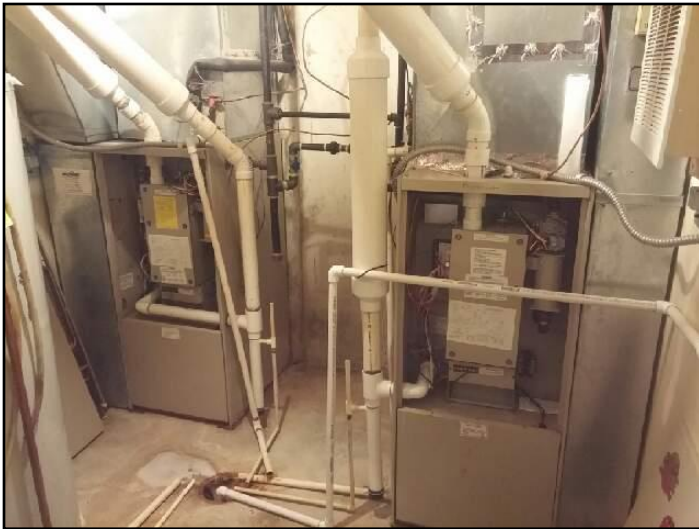
The furnace systems were old (31 years old) and beyond their useful service life expectancy. Typical life expectancy for this type of system is 18-25 years. However, the systems came to proper temperatures and were not emitting any gas at the draft hood. Although, older systems are less efficient and subject to failure. Determining the future performance of the system is beyond the scope of this inspection. The furnace systems could require repairs and/or replacement at any time. If replacement is not an option, then one may want to consider a third party home warranty plan that will cover the cost of repairs or replacement of the furnaces in the event that the furnaces become inoperative.

*Furnaces - 31 Years Old*

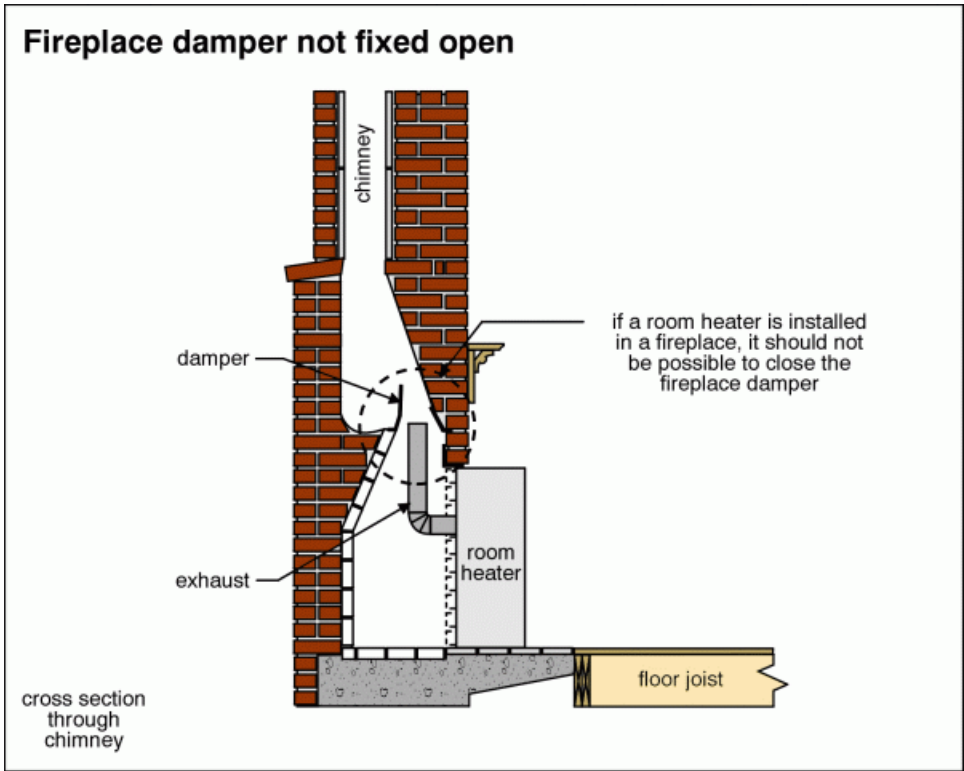
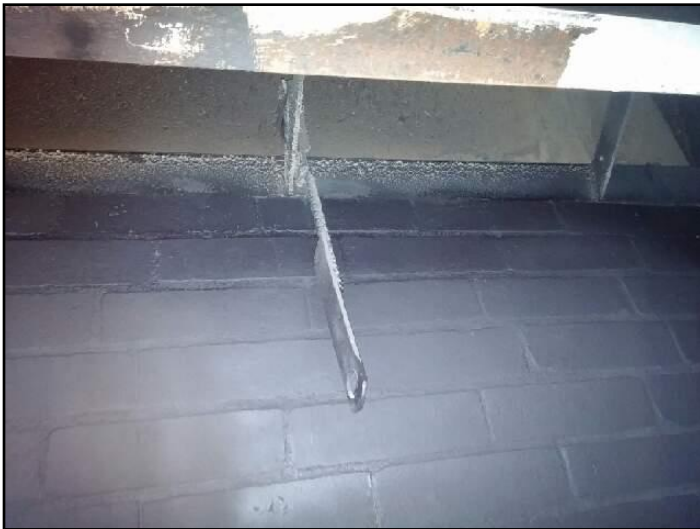
The gas fireplace damper in the living room was not in a fixed position at the time of the inspection. The damper requires a permanent damper clamp or removal of the damper, to keep the damper from closing fully, is required with a gas fireplace. Recommend having a clamp welded (permanent) or the damper removed by a qualified gas fireplace professional to ensure the safety of the occupants of the home.

*Damper Closed Position*

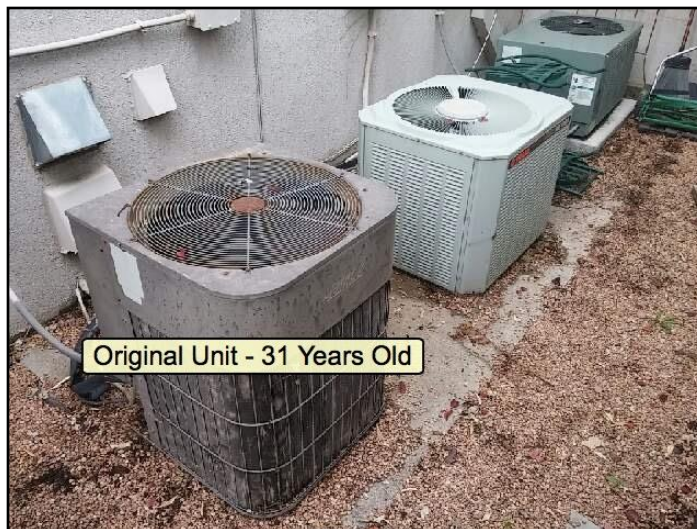
The air conditioner that serves the basement would not respond to thermostatic controls at the time of inspection. Since this unit is original to the home (31 years old), it is recommended that this AC compressor and inside coil be replaced as new refrigerant requirements are in place that are no longer compatible with the older coils.

*Lennox AC - Serves the Basement*

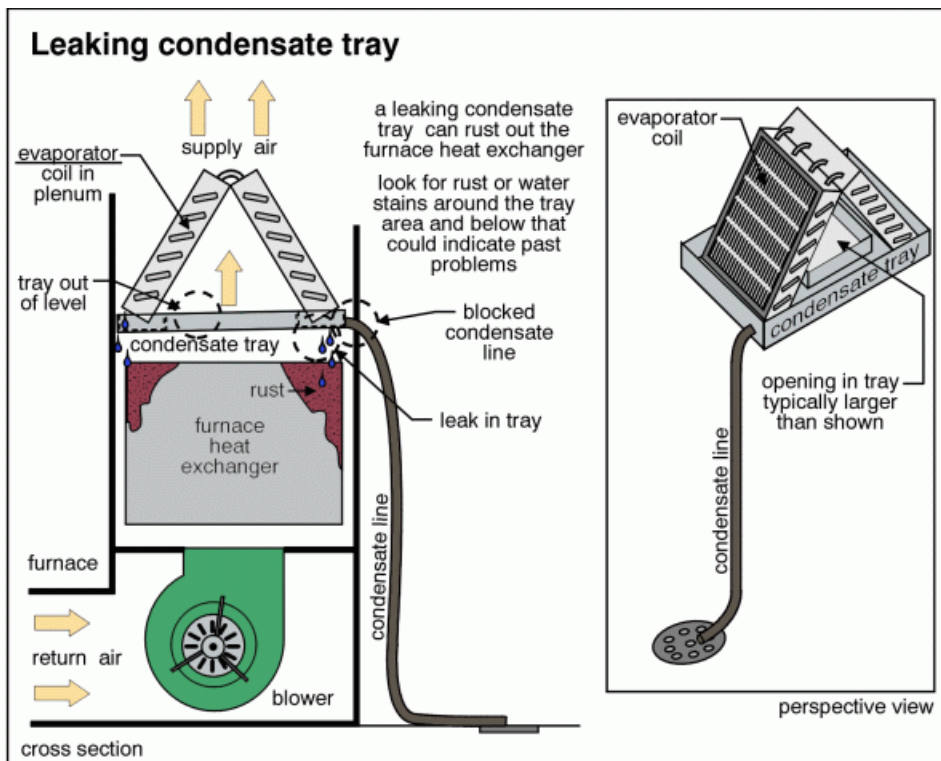
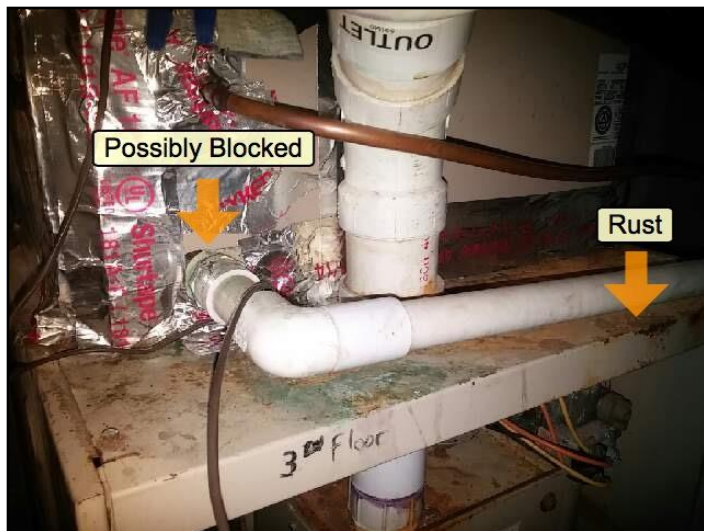
2nd Floor HVAC System

The condensate drain line for the second floor HVAC system appeared to be blocked or clogged at the time of the inspection. This may or may not have been fixed in the past, however there is significant rust on the outside and inside of the furnace cabinet, which indicates that this is still a concern that needs to be addressed. Recommend further evaluation and repairs to the condensate drain line and further evaluation of the furnace components by a qualified HVAC professional.

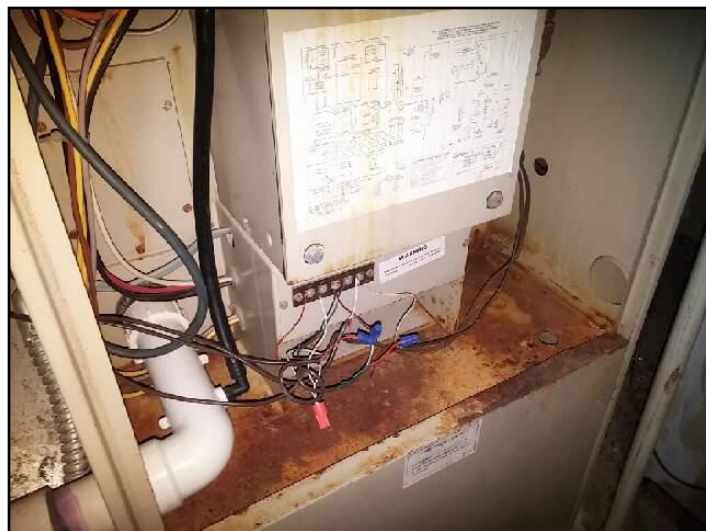
Rust Inside Furnace Cabinet

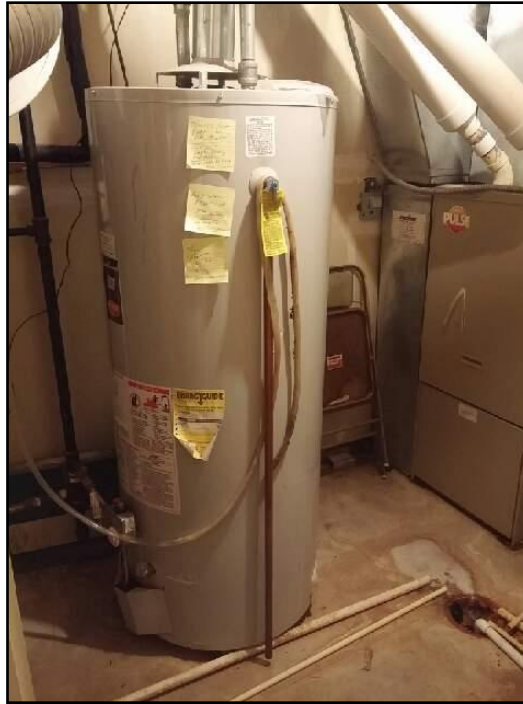
The water heater is 15 years old, and beyond the manufacturer's average (8 to 12 years) life expectancy. Older water heaters are less efficient and subject to failure. Determining the future performance of the water heater is beyond the scope of this inspection. Recommend replacement based on age alone of the water heater by a qualified plumbing professional.

*Water Heater - 15 Years Old*

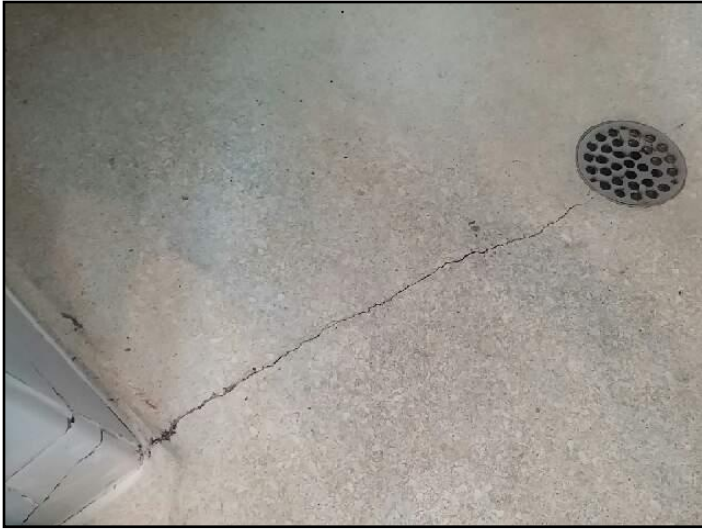
The master and basement shower pans were cracked at the time of the inspection. These cracks will eventually led to leaks if not already leaking. It could not be determined if the shower pan cracks were superficial or full cracks through the pans. Due to the condition of these shower pans, it is recommended that they be replaced by a qualified professional to prevent future leaks from occurring.

*Master Bath Shower Pan*

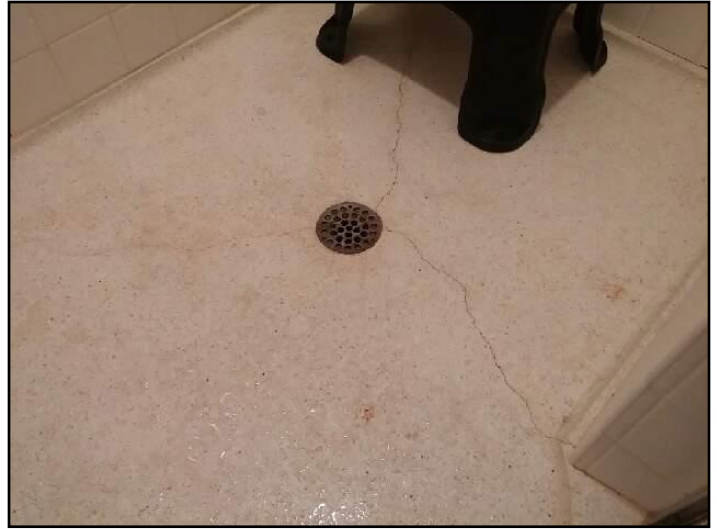
*Basement Bath Shower Pan*

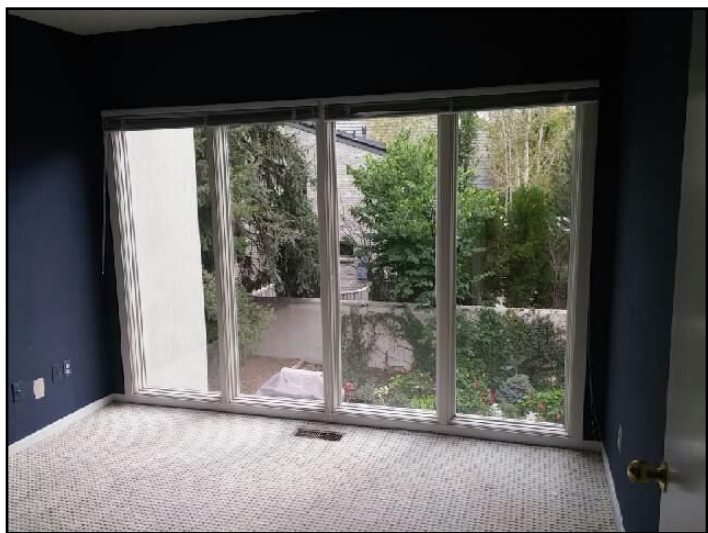
*South Bedroom Windows*

The fixed windows in the South Bedroom were less than 18" off the floor, greater than 9 sq ft of glass, and appeared to be of non-safety glass glazing at the time of the inspection as there was no marking on the glass indicating that they are of safety glazing. Safety glazing, often referred to as tempered, became part of CPSC 16 CFR 1201, and they became law on July 6, 1977. Therefore, it is recommended to consider replacement of the non-safety glass with tempered glass or installing a film, if necessary, for added safety in this hazardous location by a qualified window professional.

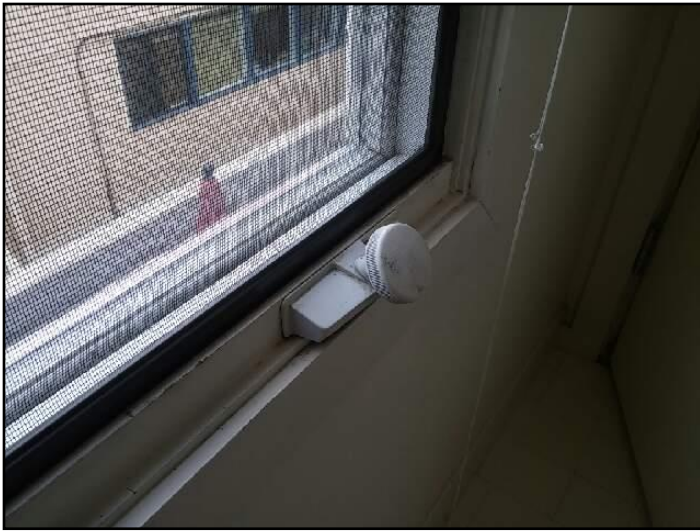
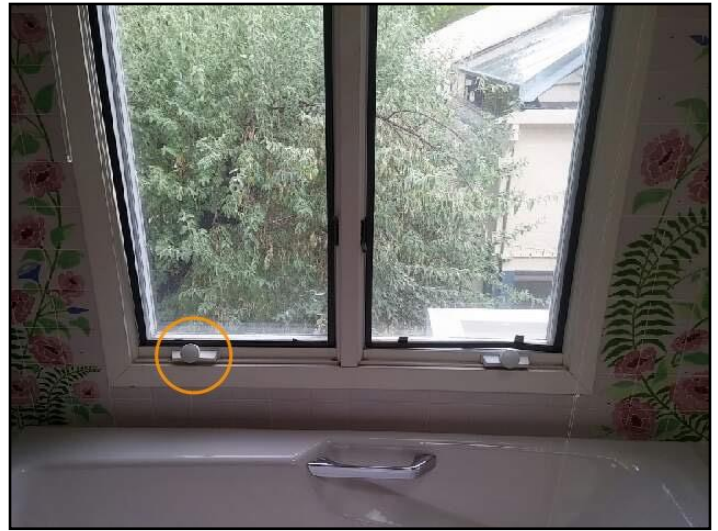
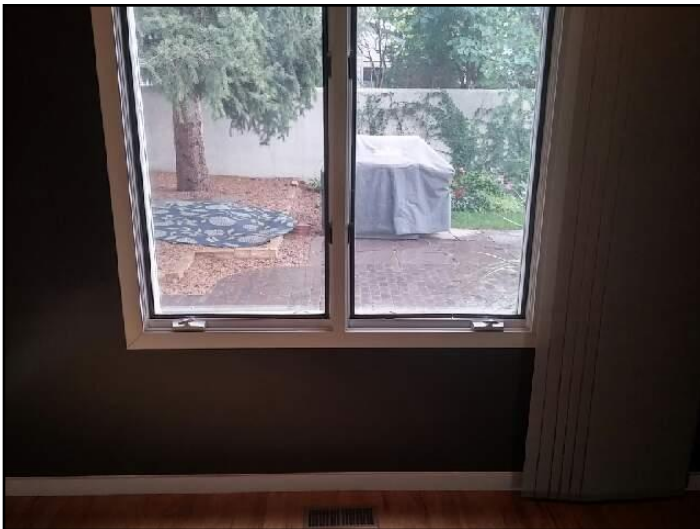
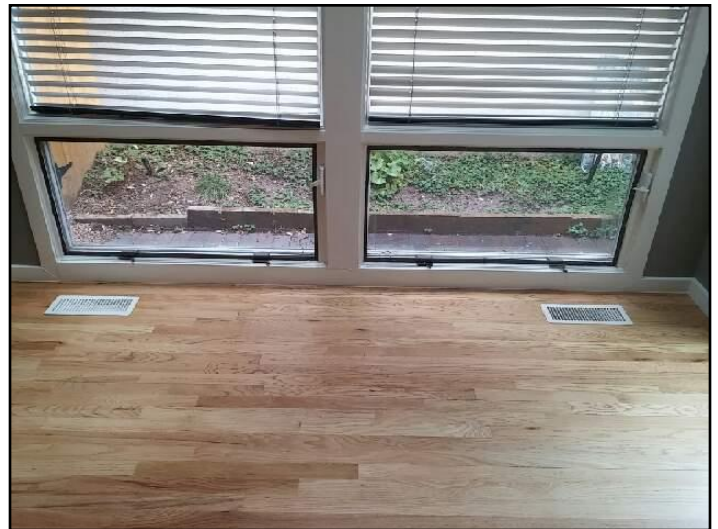
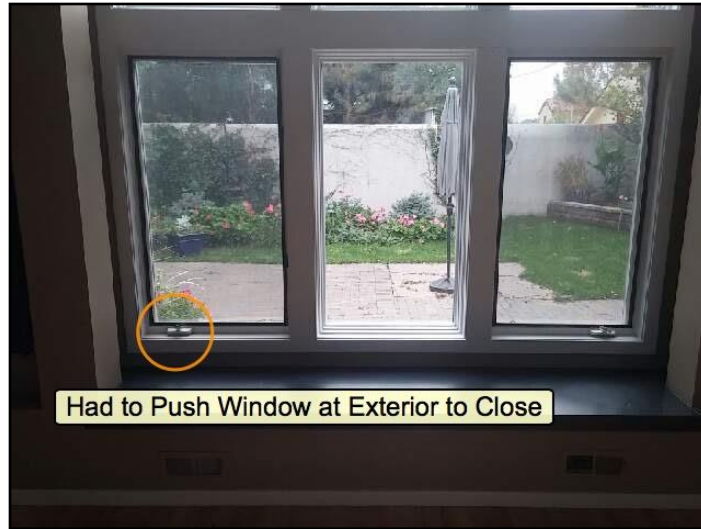
There were numerous window cranks in the home that were either stripped, inoperable, or missing at the time of the inspection. See photos for exact locations where the cranks were defective. Recommend repairs or replacement of these window cranks by a qualified window professional upon taking possession of the home.
