## PHASE 1 – Foundation & Drainage New Construction Phased Inspection Report

**John & Mary Doe**  
**5237 Clinton Street, Denver, CO 80238**

Vango Inspections | PO Box 13606, Denver, CO 80205 | Phone: (303) 250-8444

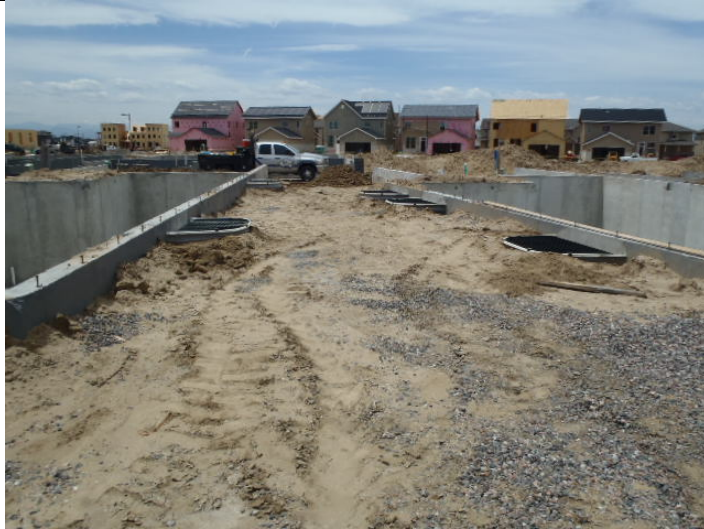
The soil was lightly compacted at the time of the inspection. The grading around the home was relative flat and sloping away from the foundation. This will continue to be worked until final grade is in place at time of the FINAL inspection. We will continue to evaluate the grading in between the residences to ensure that a proper swell is in place to help manage water run-off.

Proper grading is critical to the future success of the homes foundation. Many builders try to slope the lot  $\frac{1}{4}$ " per 1'.

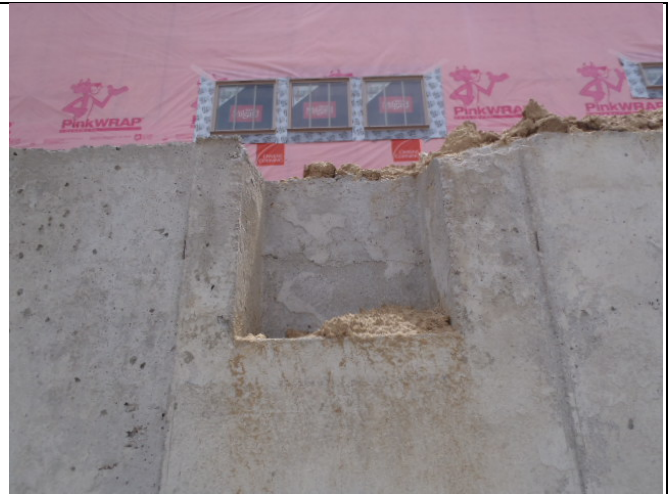
Beam Pockets – Cut Into Place

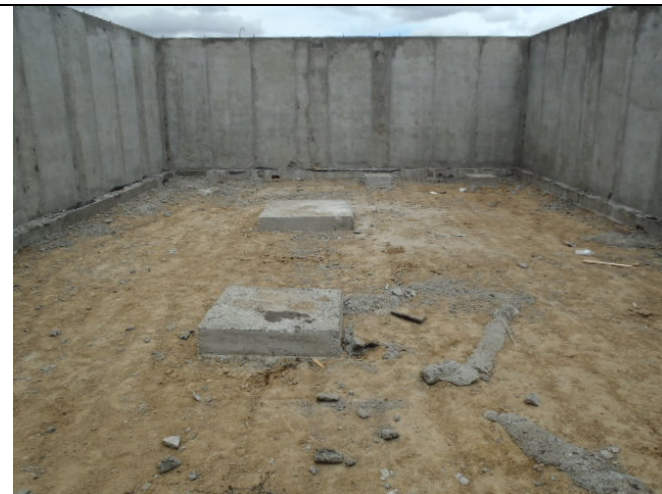
Pier Pad – Prior to Slab Being Poured

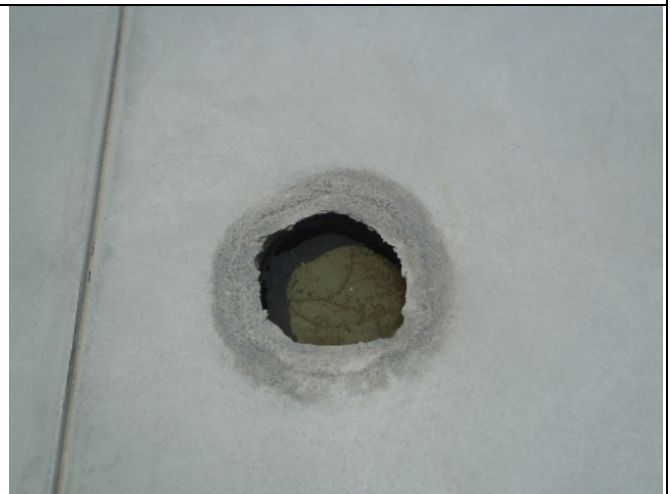
Pier Pads in Place – Column Attachment Sites

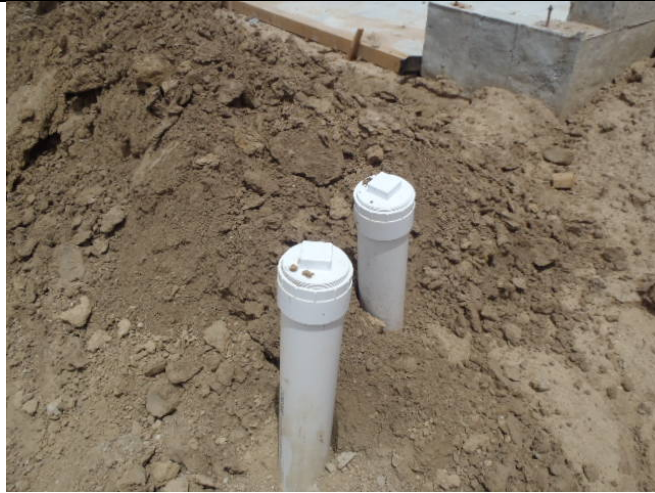
Sewer Clean Outs – South Exterior Garage

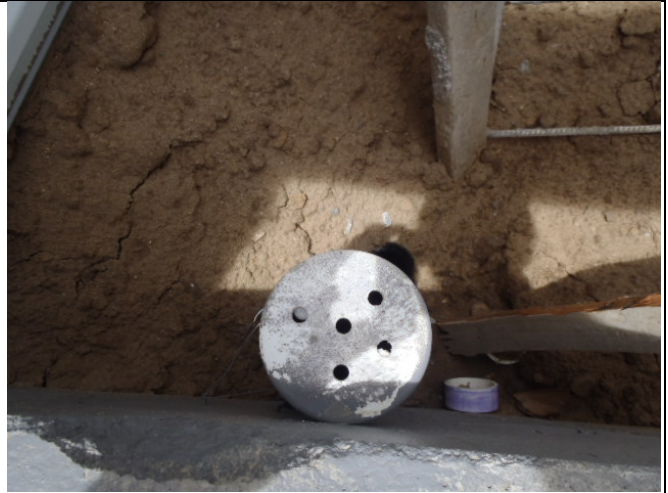
Window Well Drains – Each Basement Window

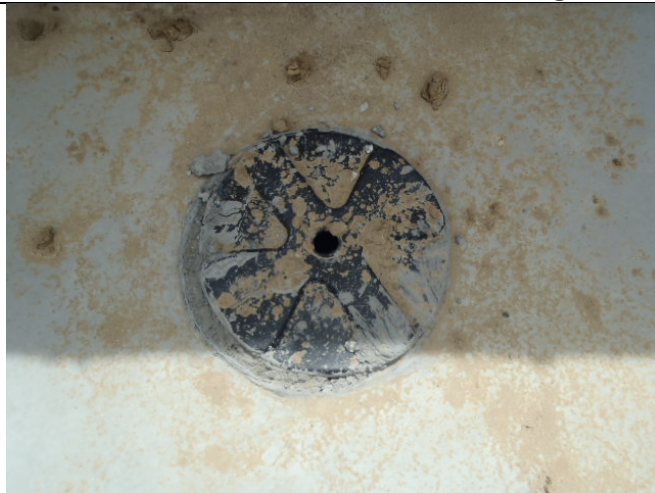
Sump Pit

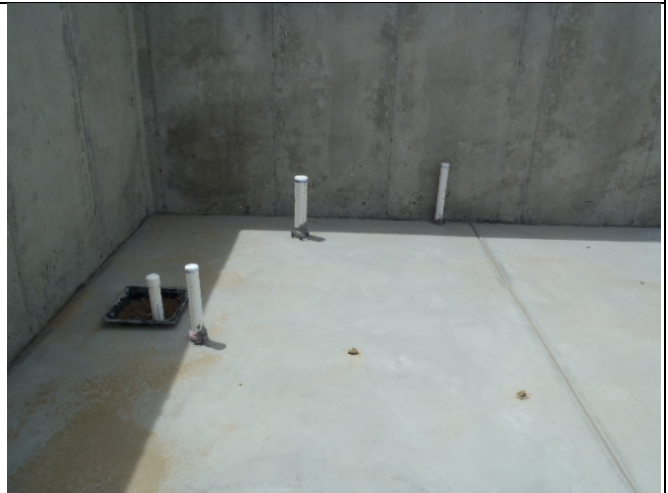
Roughed In Plumbing

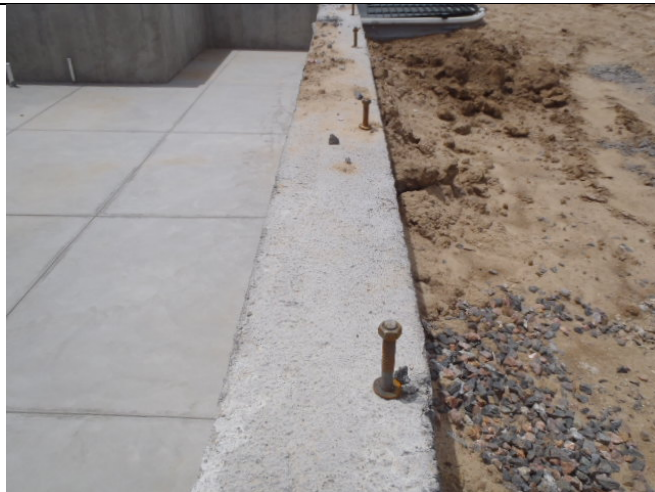
Anchor Bolts – Wall Attaches to these Bolts

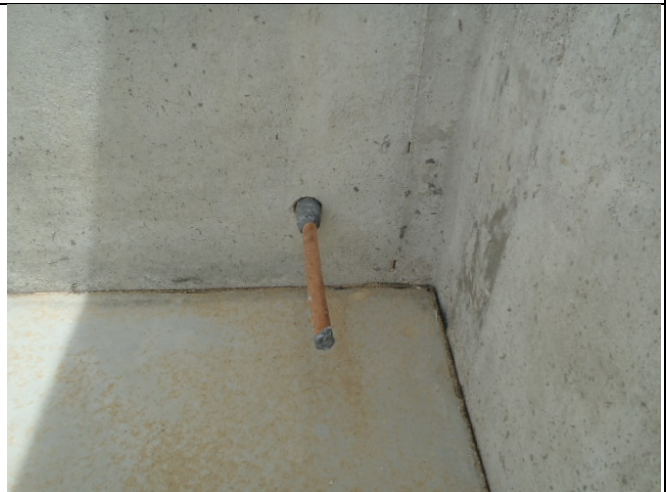
Main Water Line Plumbed – East Wall

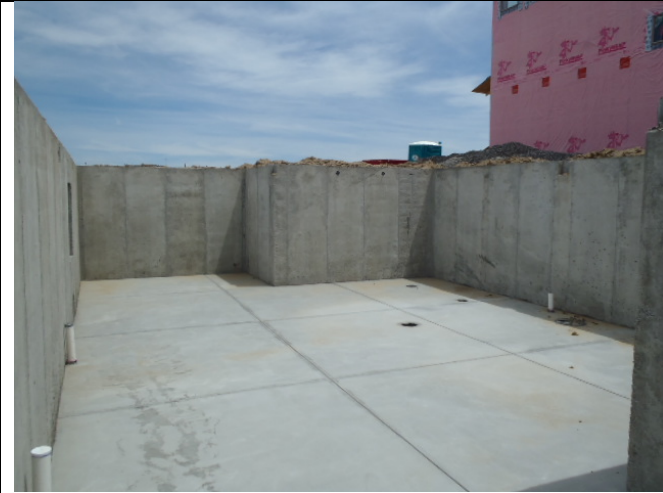
**Basement Slab – Control Joints Cut In**

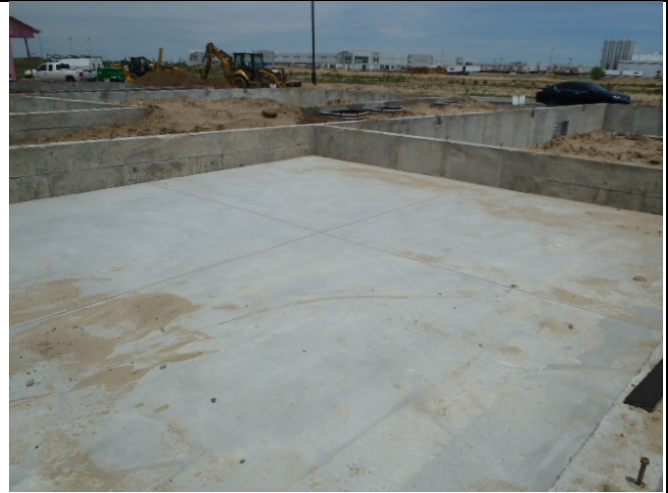
**Garage Slab – Control Joints Cut In**

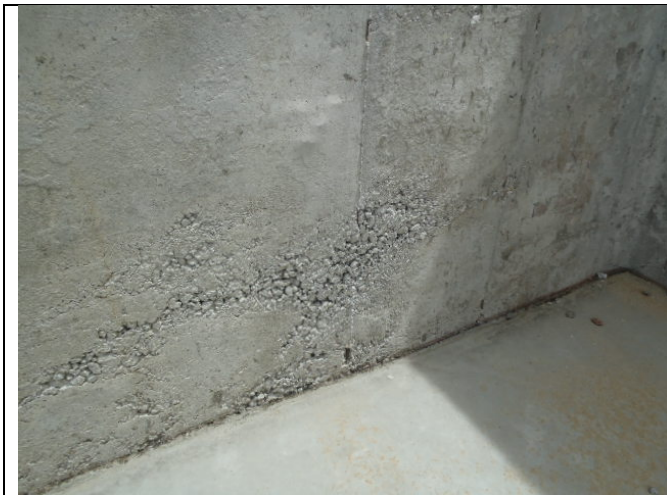
When the foundation walls are poured, many times during the end of a pour lumpy aggregate becomes part of the foundation wall. Depending on where this aggregate builds up, depends on whether or not additional work is needed. Since the aggregate ended up towards the bottom of the foundation wall, on the South and East sides, additional work should be performed to these sections of wall. See below for further recommendations:

**East Wall – Aggregate At Bottom of Wall**

**Recommend having these sections of wall skim coated with additional concrete to prevent the aggregate from becoming displaced from the foundation wall by a qualified concrete professional.**

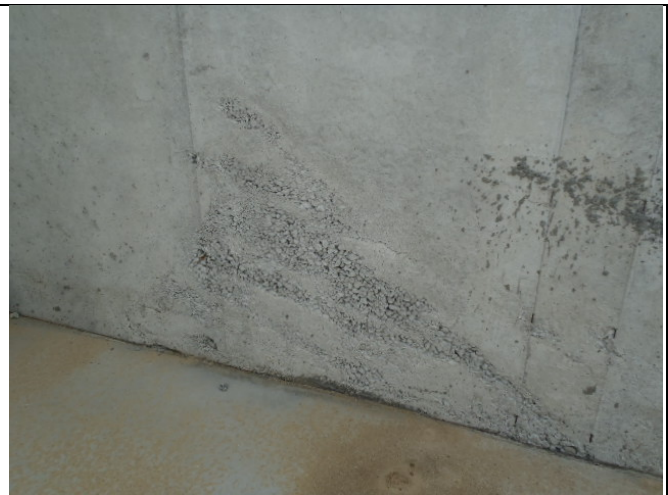
**South Wall – Aggregate At Bottom of Wall**
