## PHASE 2 – Framing, Mechanical & Delivery Systems New Construction Phased Inspection Report

**John & Mary Doe**  
**5237 Clinton Street, Denver, CO 80238**

Vango Inspections | PO Box 13606, Denver, CO 80205 | Phone: (303) 250-8444

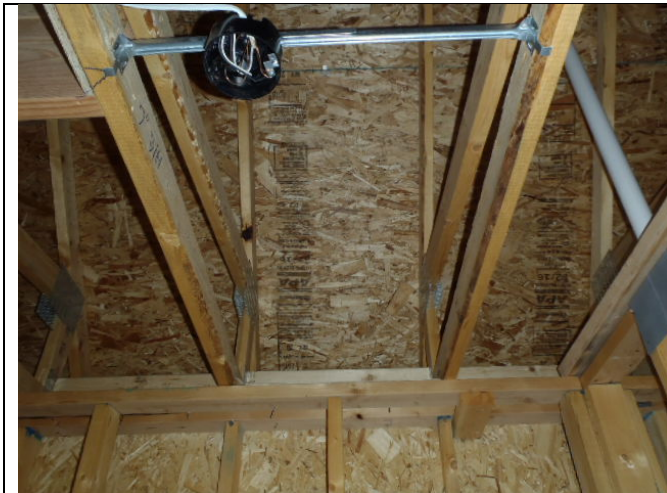
- 5) Soffit baffles were NOT installed in the attic to prevent insulation from blocking these vents when the attic insulation is installed. These will be installed prior to the installation of drywall;

Soffit baffles are NOT in place to prevent insulation from blocking the soffit vents when the insulation is installed. These baffles are typically installed prior to the drywall installation.

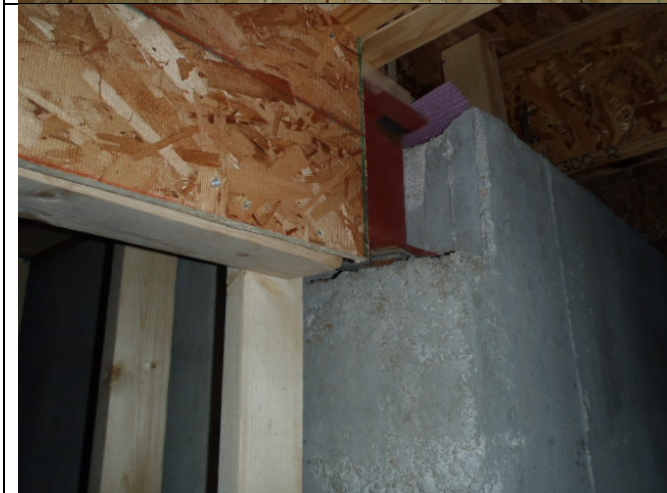
- 6) The lot grading will continue to evolve throughout the building process, but final grade will be sloping away from the home's foundation;
- 7) The basement beam pockets were not grouted into place at the time of the inspection. These beam pockets are typically grouted in prior to drywall installation. Check with the builder as to when this occurs in their building process;

The steel beams in the basement had not been grouted into place at the time of the inspection. This usually occurs once the framing is in place and the City has conducted their framing inspection.

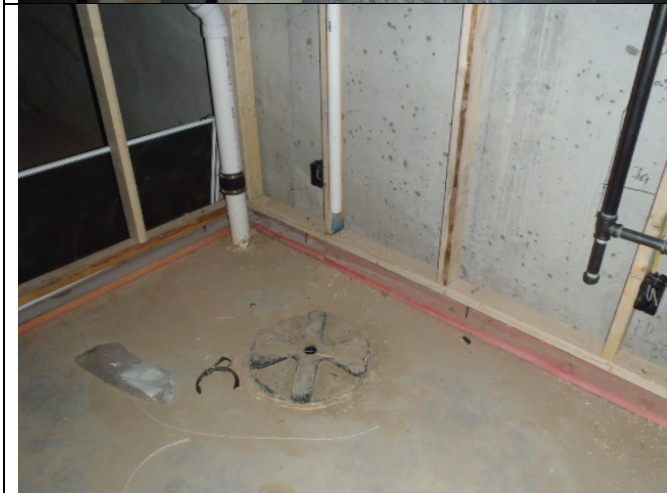
- 3) Roof level plumbing stack vent pipes are already painted to protect them from UV breakdown;
- 4) The sump pit had a small amount liquids present in the pit at the time of the inspection. A pump and discharge pipe was installed at the time of the inspection. The sump pit will be evaluated during the final inspection to ensure that a pump is working properly;

The sump pit had a discharge pipe to the exterior installed at the time of the inspection. This is an indication that a pump will be installed in the pit.

This will be evaluated during the FINAL inspection to ensure that the pump is operational.

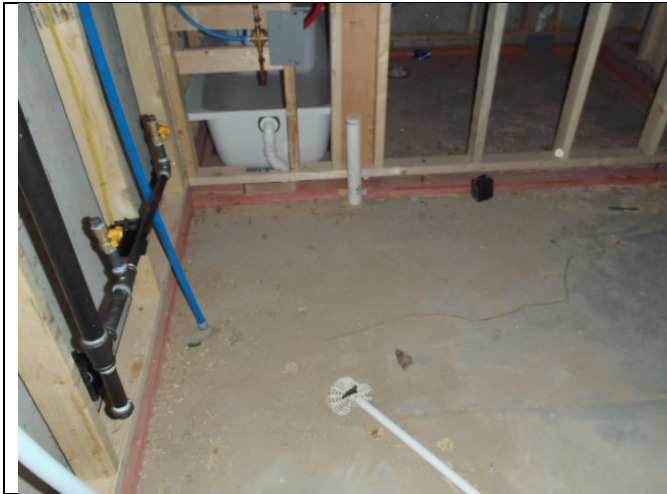
- 8) The basement floor vent was vented by the air admittance (studor) vent has not been installed. This typically occurs when they have to pressurize the system for the final plumbing inspection with the City;

The basement floor drain had a vent present, however an air admittance (studor) vent was not installed. This usually occurs prior to the City's FINAL plumbing inspection.

This will be verified during the final inspection.

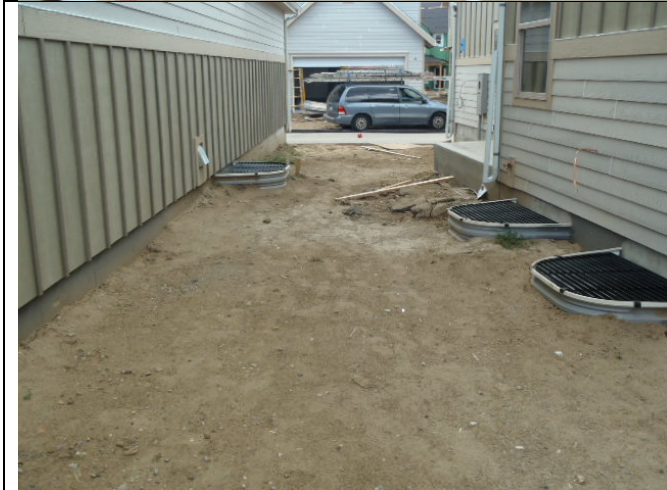
The grading around the proper is not to FINAL grade as of yet. This occurs at the final stages of the home building process. It is imperative that we have lot slope that moves away from the home's foundation.

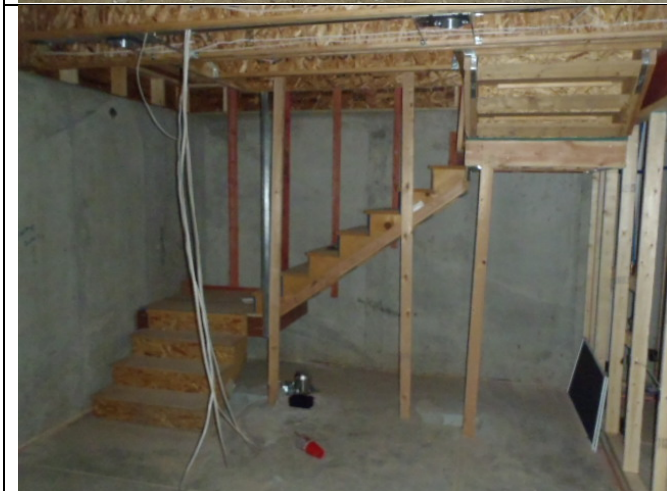
There were 2x4 temporary posts placed under the basement staircase. Two steel columns will replace these temporary posts to ensure long-term stability.

Inquire of the builder as to when this occurs within their build-out process.

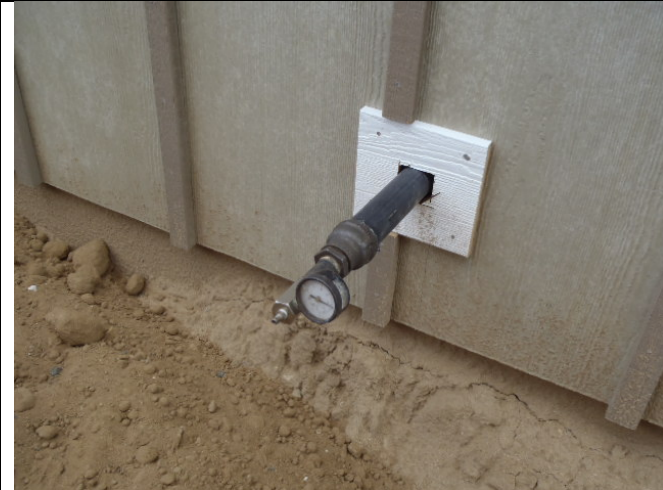
The main gas line inside the home has been installed. The builder is waiting on Xcel contractors to install the meter itself. Once that occurs a pressure test will occur. The pressure gauge is installed for the pressure test.

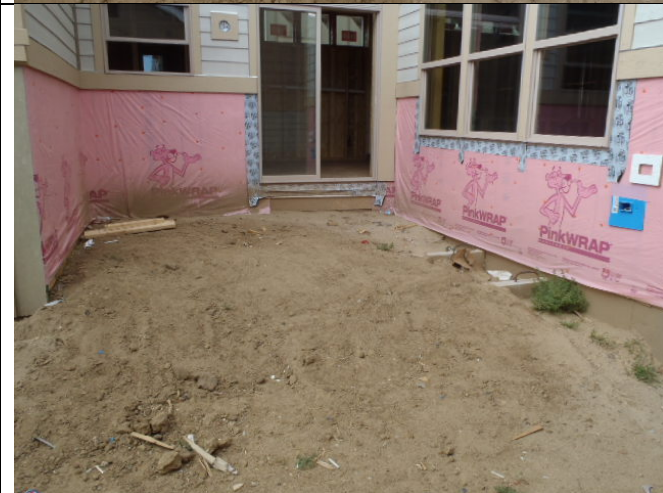
The rear patio has not been poured. Before they pour this concrete patio, metal flashing will be installed around the perimeter of the exterior walls to prevent the walls from becoming damaged from the moisture content within concrete.

Consult the builder as to when the rear patio will be poured into place.

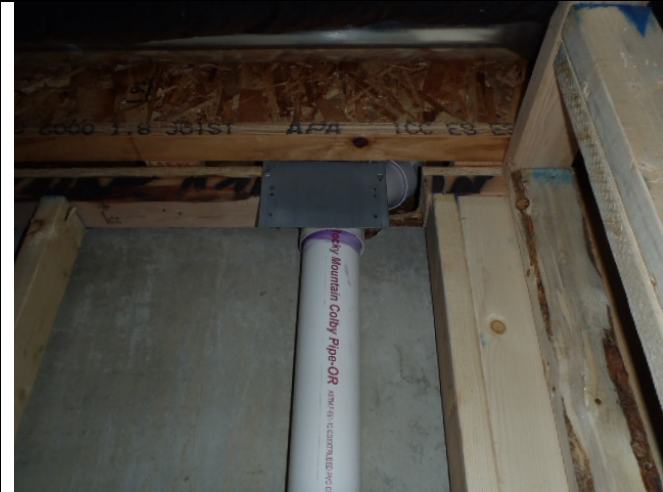
There was a plumbing nail plate on the North wall of the basement bedroom that was not of proper size, see photo.

Recommend installing a nail plate that fits the entire opening so that it does not become difficult in hanging the drywall.

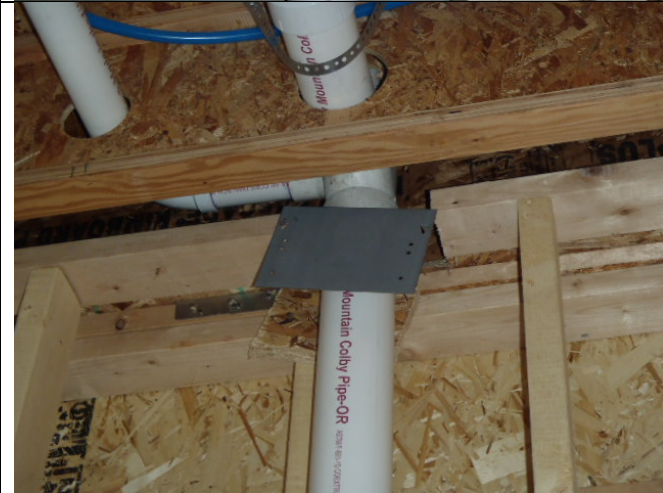
There was a plumbing nail plate on the North wall of the Butler's pantry that was loose.

Recommend having this nail plate properly secured to the 2x4 by a qualified plumbing professional.

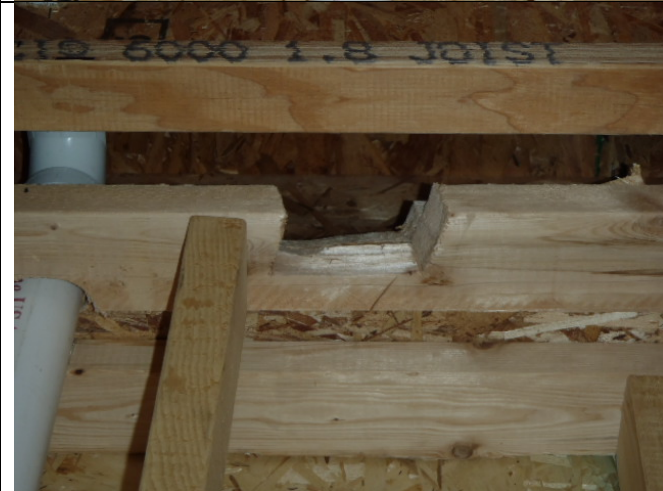
There was a missing nail plate on the North wall of the basement living room at the time of the inspection.

Even though this nail plate is not protecting something from becoming punctured, it is bridging a gap in the framing that will make it easier to secure drywall to the wall.

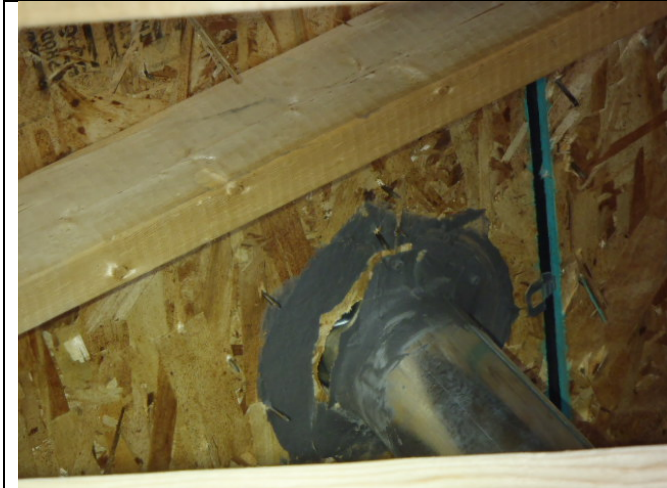
The laundry room vent fan duct, where it terminates to the exterior through the roof, had mastic that was damaged.

Recommend having additional mastic installed around this vent duct where it exits through the roof by a qualified HVAC professional.

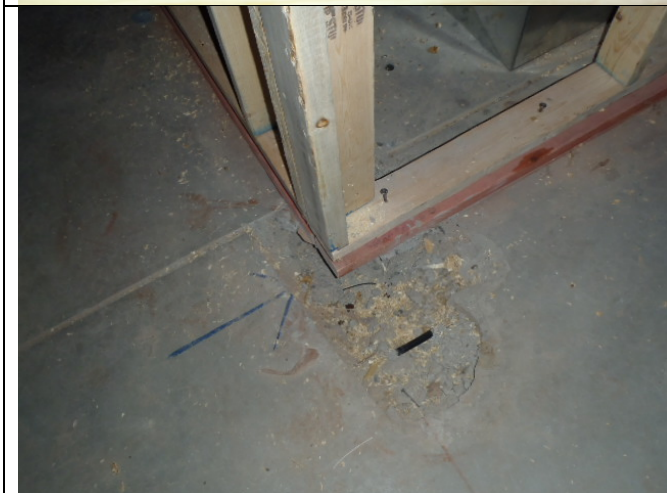
There was a pier in the basement that appeared to be covered and then uncovered. This pier is used to secure a steel column to support the steel I-beam above. However, it appears that the wall assembly for the basement mechanical room was built over the top of this pier.

Recommend consulting the builder to determine next appropriate steps to ensure that the column is installed.

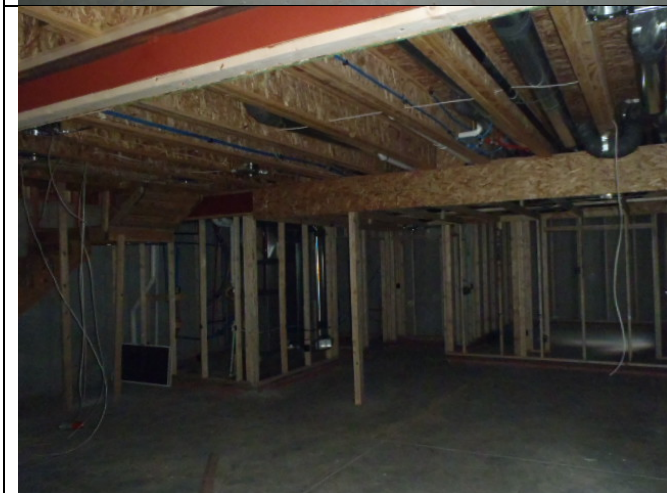
This pictures shows the temporary wood post supporting the steel column in the basement.

See the notes above for what should be done next.

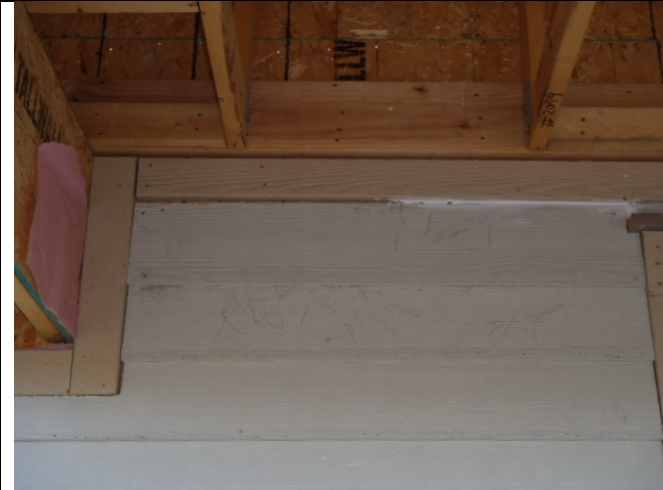
The top piece of siding on front porch West wall had a gap too large to use caulking.

Recommend having the siding adjusted on this wall to minimize the gap between the siding the upper trim board by a qualified siding professional.

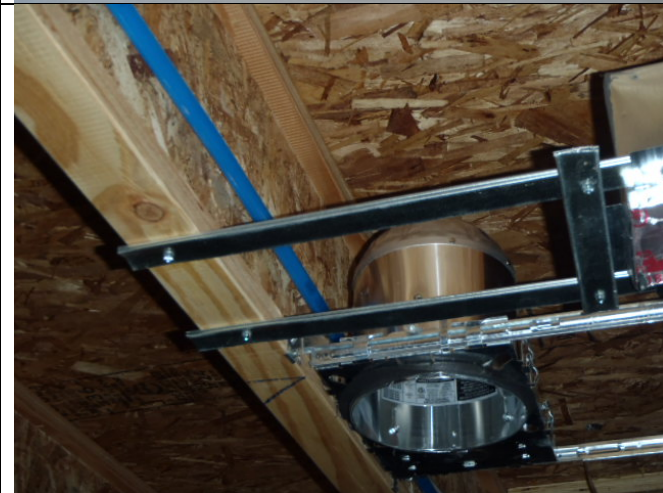
There was a water line that ran too close to a can light fixture in the basement living room ceiling.

Anywhere a water line runs within 2" of a can light fixture, some type of insulation should be installed on the water line to prevent the light fixture from melting the plastic water line.

Recommend repairs to this water line by a qualified plumbing professional.

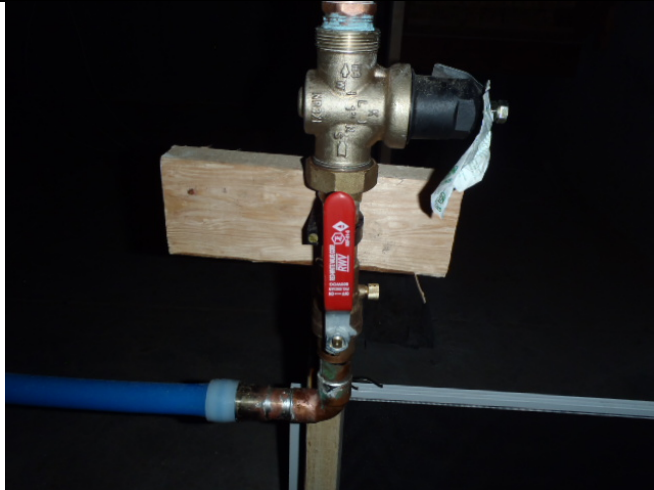
The main water shut-off valve is located on the East wall of the basement mechanical room. There is also a main water shut-off valve on the East wall of the basement living room.

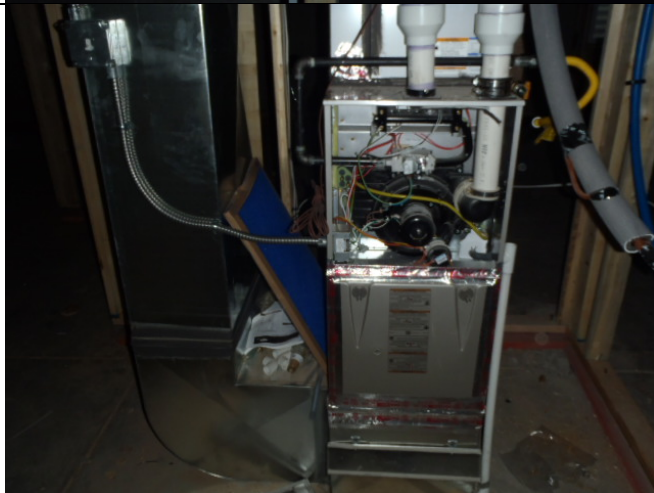
The furnace was installed with the AC coil in the basement. Installation of this system is appropriate. The system will be tested during the FINAL inspection.

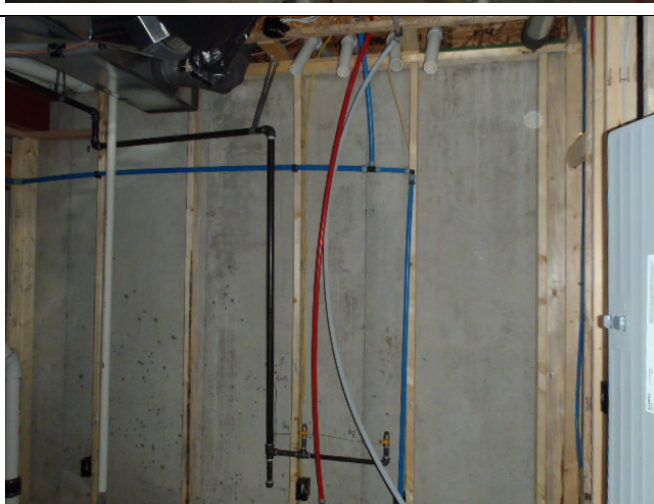
The home is plumbed for a tankless water heater in the basement. All components are present, however the tank typically does not get installed until the home can be properly secured.

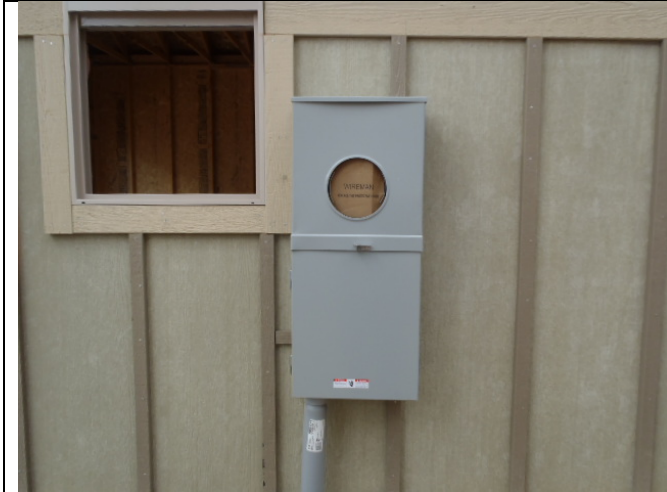
**The main electrical panels and disconnects are located on the South exterior garage wall.**

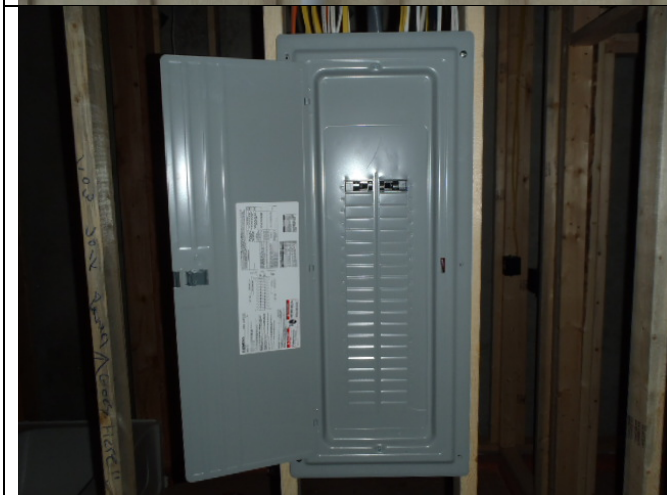
**The electrical distribution panel is located on the West wall of the mechanical room in the basement.**
