INSPECTION REPORT

For the Property at:
27 MAPLE CRESCENT
CHICAGO, IL

Prepared for: JOHN SIMPSON
Inspection Date: Thursday, January 4, 2007
Prepared by: Alan Carson

RE: Report No. 1366, v.6
27 Maple Crescent
Chicago, IL

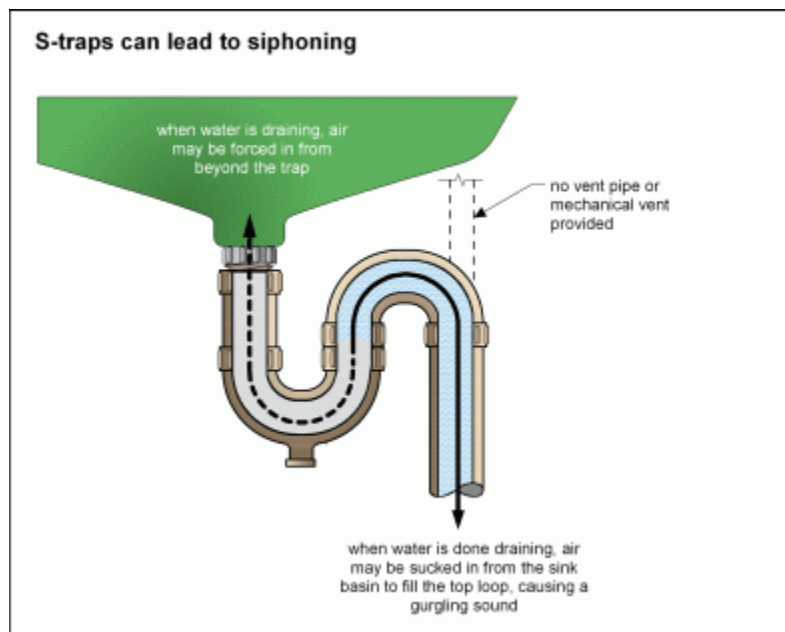
Note: This configuration is prone to clogging problems

Time: Less than 1 year
