# YOUR INSPECTION REPORT

1840 E. Cedar Avenue  
Denver, CO 80209

Friday, October 23, 2015

RE: Report No. 3912, v.2  
1840 E. Cedar Avenue  
Denver, CO  
80209

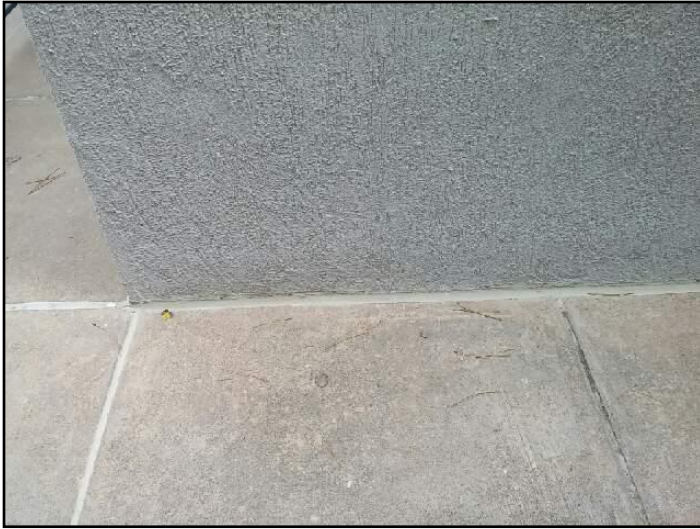
The seller disclosed that they had to have the stucco repaired on the front side of the home due to moisture intrusion. It appears that repairs were made, however there was a very musty smell in the master bedroom during the inspection. This is a possible indication that water may have entered inside the wall cavity and was not addressed properly during the stucco repairs. This raises concerns related to possible mold and material deterioration inside the wall cavity. Recommend further evaluation and a mold test be conducted by the appropriate professionals.

*Sealed the Stucco at Front Patio*

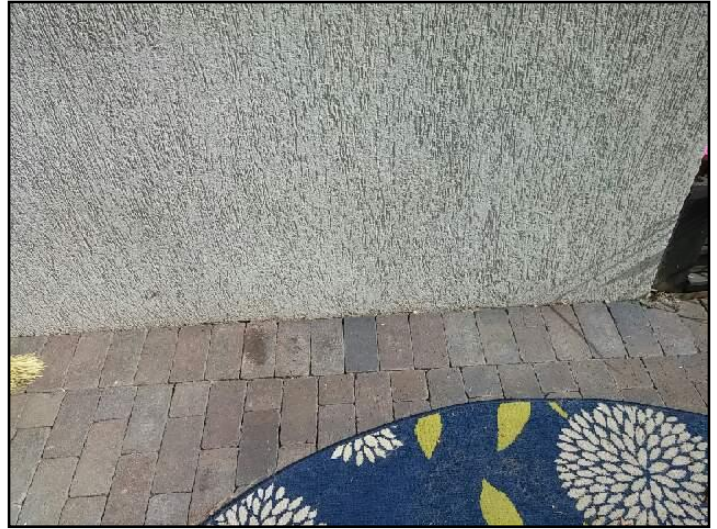
The stucco was too close to grade and in contact with concrete at various points at the exterior wall (see photos), at the time of the inspection. There were no real regulations on stucco installation until 1997. Stucco should be at least 4" from soil and 2" from concrete type surfaces. Recommend having the stucco evaluated by a qualified stucco professional to determine what steps can be taken to ensure that the stucco wall will drain properly, since the previous owners disclosed that they had moisture penetration occur on the front side of the home.

*Stucco Below Rear Paver Patio*

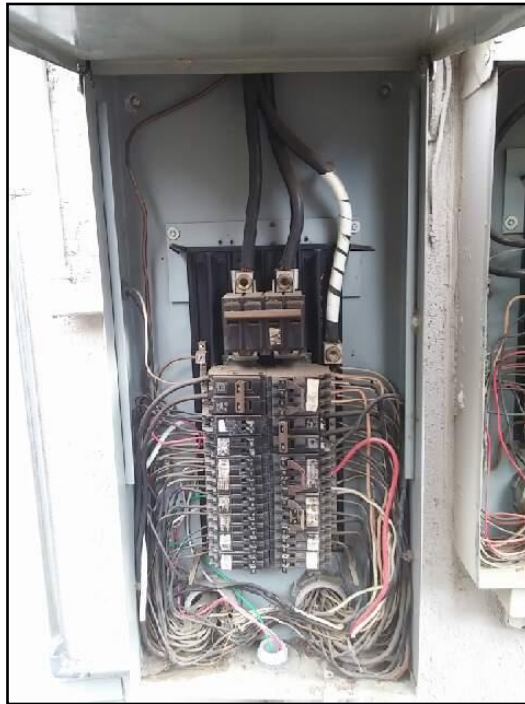
*Electrical Distribution Panel*

There was a single pole circuit breaker improperly double tapped, at the electrical distribution panel, with two wires entering the single pole breaker (see photo). Most circuit breakers and other electrical connections are only rated (UL listed) to safely hold one wire. Double tapping is when 2 or more wires connect to one circuit breaker or electrical lug. Recommend repairs to these circuit breakers by a qualified electrical professional, keeping in mind that there is a spare circuit breaker already in the panel that can be used for one of these wires.

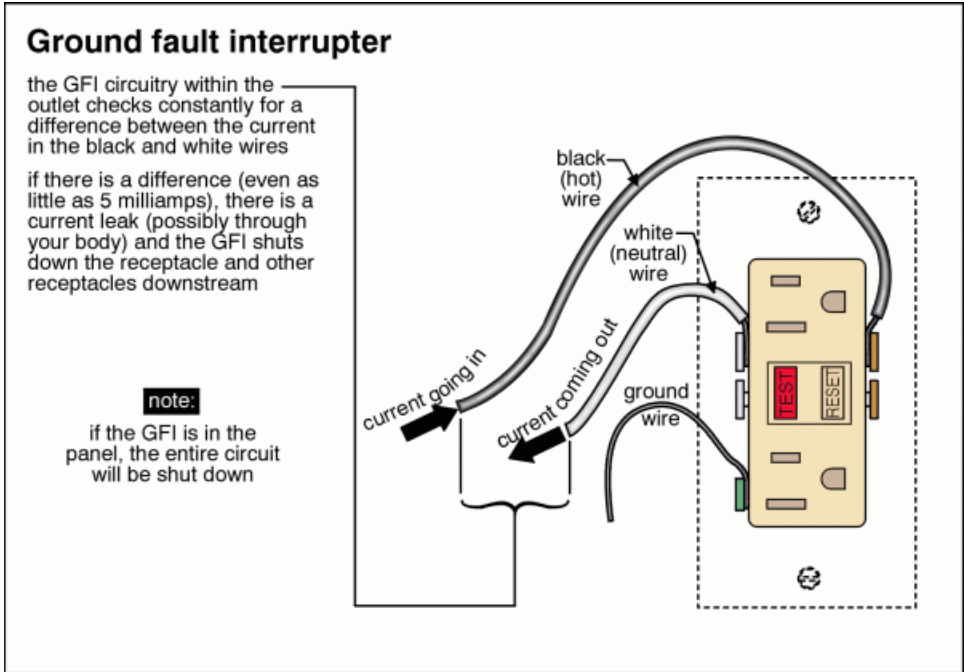
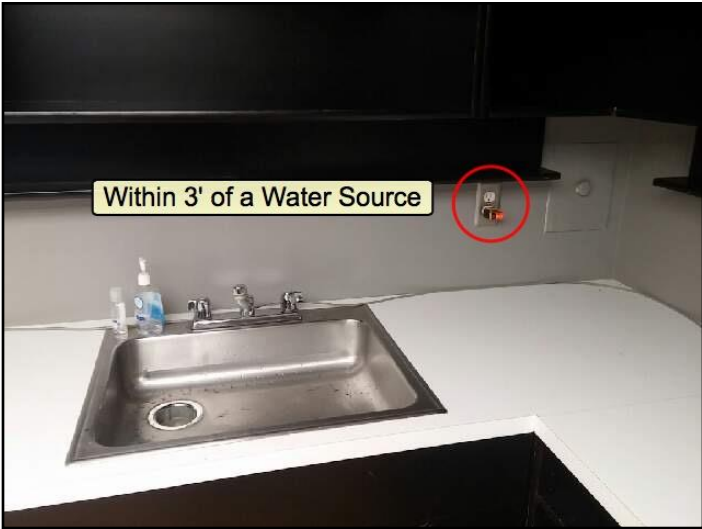
Work Room

**Condition:** • [Test faulty on Ground Fault Circuit Interrupter \(GFCI\)](#)

**Task:** Upgrade - Replace

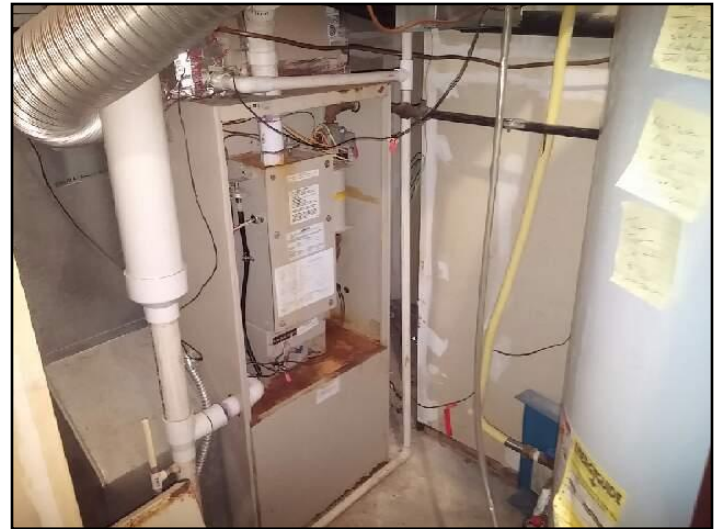
The furnace systems were old (31 years old) and beyond their useful service life expectancy. Typical life expectancy for this type of system is 18-25 years. However, the systems came to proper temperatures and were not emitting any gas at the draft hood. Although, older systems are less efficient and subject to failure. Determining the future performance of the system is beyond the scope of this inspection. The furnace systems could require repairs and/or replacement at any time. If replacement is not an option, then one may want to consider a third party home warranty plan that will cover the cost of repairs or replacement of the furnaces in the event that the furnaces become inoperative.

*Furnaces - 31 Years Old*

*Third Furnace*

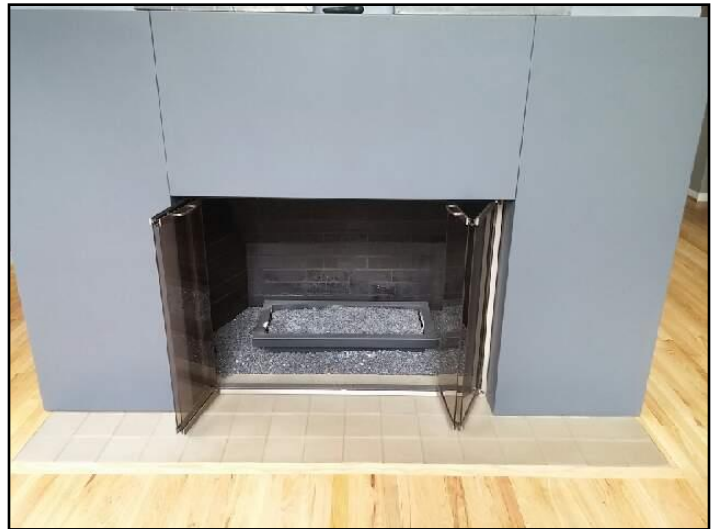
The gas fireplace damper in the living room was not in a fixed position at the time of the inspection. The damper requires a permanent damper clamp or removal of the damper, to keep the damper from closing fully, is required with a gas fireplace. Recommend having a clamp welded (permanent) or the damper removed by a qualified gas fireplace professional to ensure the safety of the occupants of the home.

*Gas Fireplace*
